AIRCRAFT ACCIDENT INVESTIGATION DEPARTMENT

PRELIMINARY REPORT

OPERATOR/OWNER	: Ninety-Nines Flying School
MANUFACTURER/AIRCRAFT TYPE	: Textron Aviation Inc. /Cessna 172M
YEAR OF MANUFACTURE	: 1976
AIRCRAFT REGISTRATION	: 5Y - NNJ
AIRCRAFT SERIAL NUMBER	: 172-65726
DATE OF REGISTRATION	: 2 August 2018
NUMBER AND TYPE OF ENGINE	: One, Lycoming O-320-E2D
DATE OF OCCURRENCE	: 15 October 2020
TIME OF OCCURRENCE	: 1337 (1637)
LOCATION OF OCCURRENCE	: Wilson Airport
TYPE OF FLIGHT	: Training
NUMBER OF PERSONS ON BOARD	: Two
INJURIES	: Nil
NATURE OF DAMAGE	: Minor
CLASS OF OCCURRENCE	: Incident
STUDENT PILOT	: PPL Holder
STUDENT FLYING EXPERIENCE	: 128 Hours

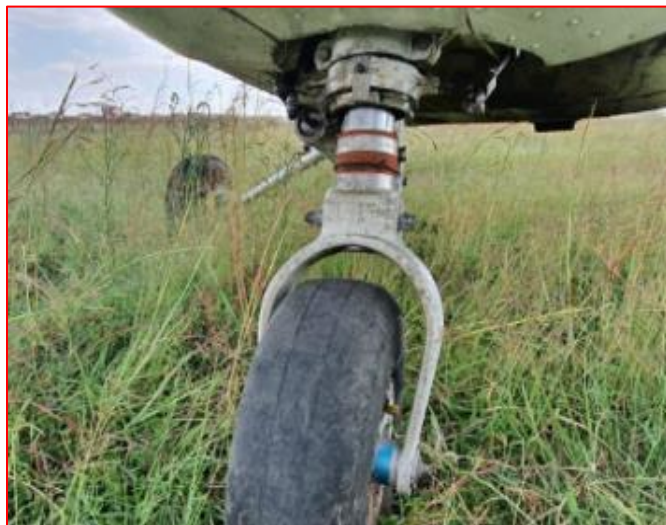
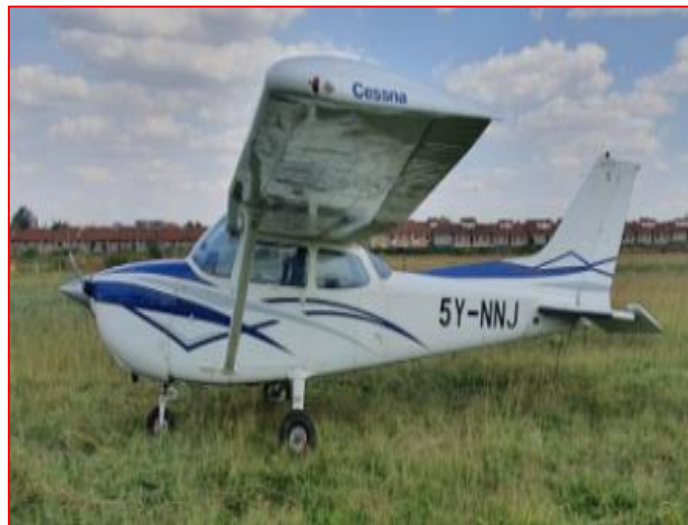
Photos of 5Y-NNJ after the occurrence on 15 October 2020.

The aircraft sustained damage to the nose wheel steering link assembly. There was no post-crash fire.

Safety issues identified was the need for the approved training organizations to enhance their CESSNA 172 training programmes to ensure student pilots are adequately trained for operations in abnormal conditions, and for the instructor pilot to remind the student pilot about the correct aircraft handling techniques before each landing during emergencies.
