AIRCRAFT INCIDENT INVESTIGATION DEPARTMENT

PRELIMINARY INVESTIGATION REPORT

**INCIDENT TO THE AIRCRAFT 5Y-NNS, CESSNA C-172N ON
16.02.2021 AT WILSON AIRPORT, NAIROBI COUNTY**

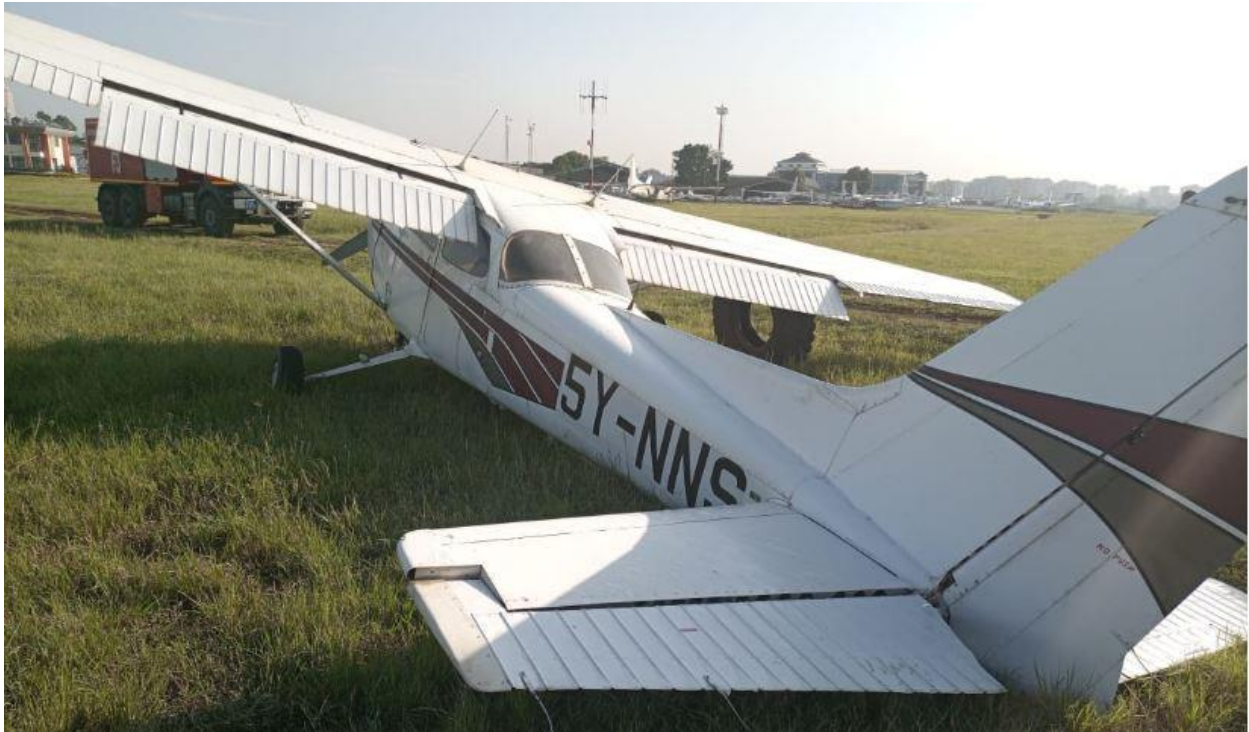
Figure 1: The aircraft in a grassy area within the confines of the Aerodrome

The aircraft sustained minor damage on the right main landing gear attachment point and the right-hand horizontal stabilizer.

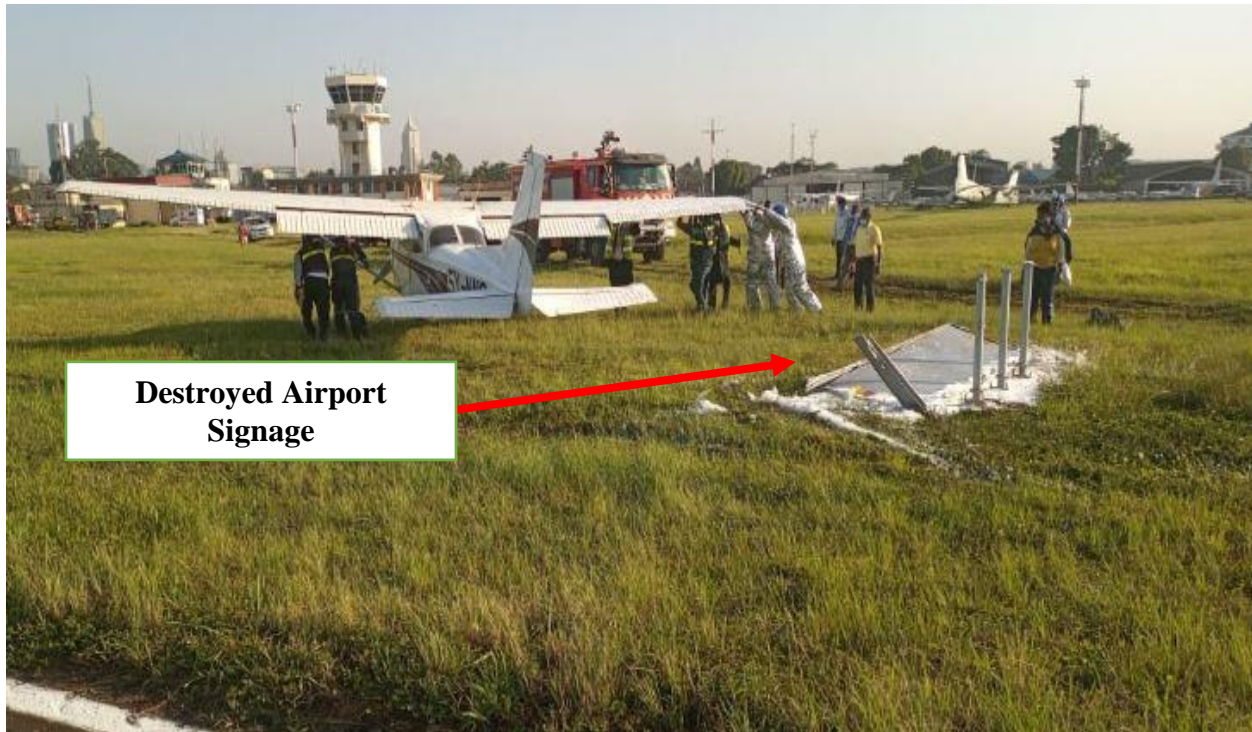
Figure 2: The destroyed airport Signage within the Aerodrome

The runway signboard was dislodged from the stand.

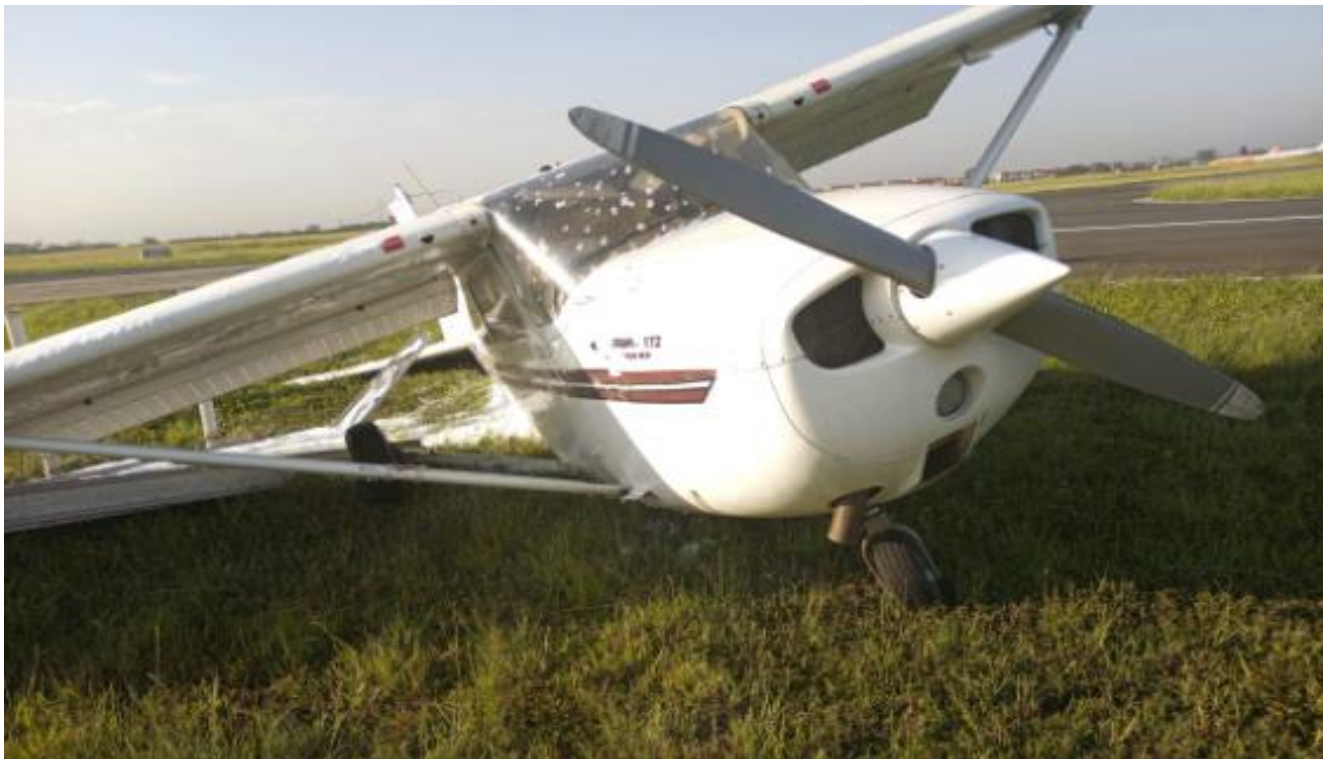
The right-hand wing came into contact with the ground.

Figure 4: The front section of the aircraft after the final stop

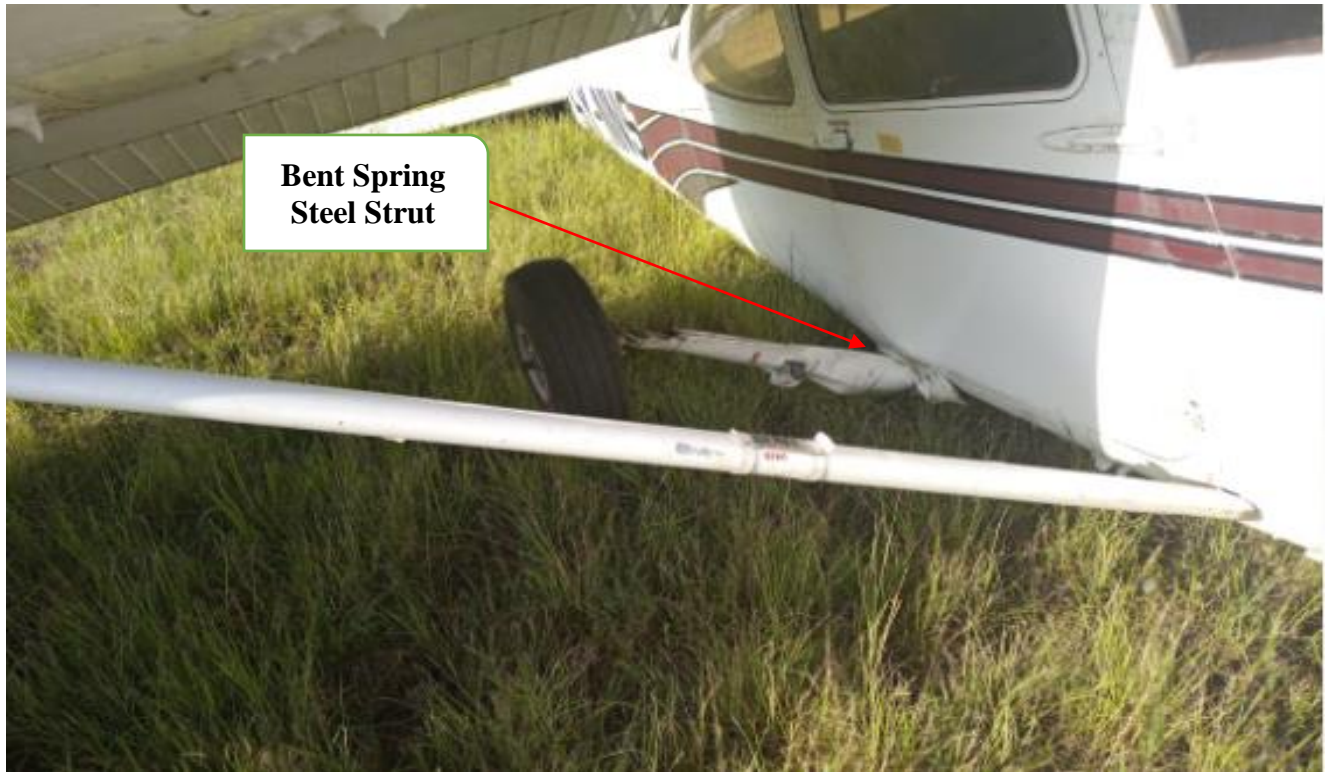
To remove the aircraft from the location, the right-wing was lifted manually and thereafter the right main landing gear strut was forced down to support the fuselage. The aircraft was then pushed to the hangar.

Figure 5: The section of the bent spring steel strut after the incident

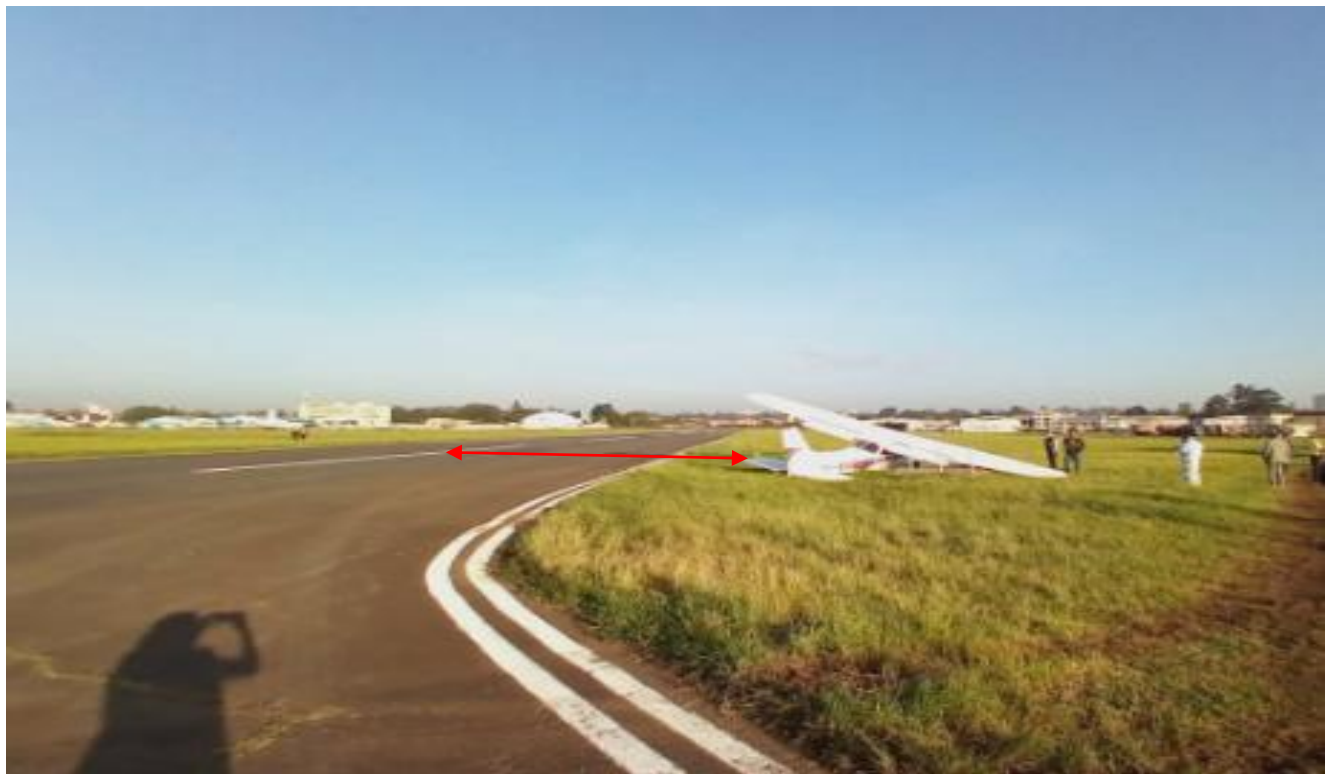
The aircraft came to a final stop about 20 meters from the runway.

Figure 6: Final resting point from the center of the runway

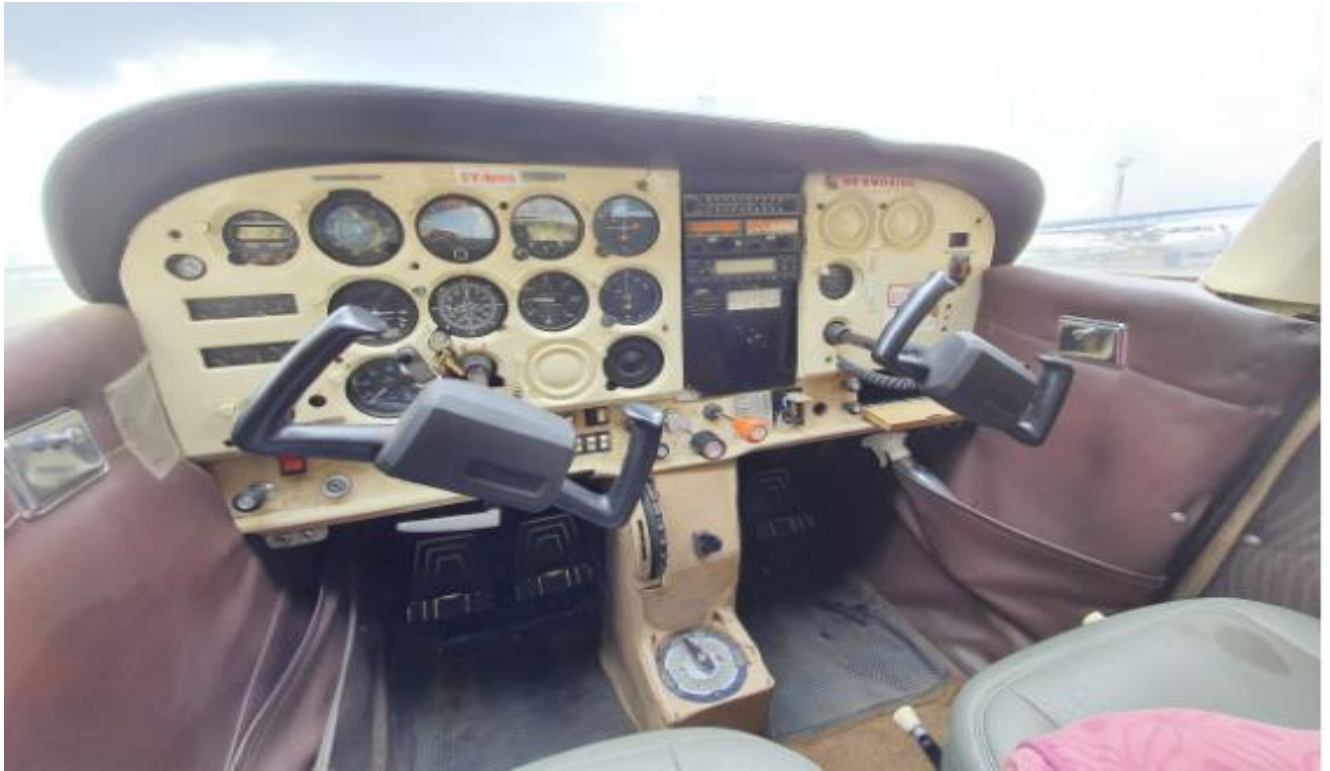
Figure 7: The cockpit after the Incident
