AIR ACCIDENT INVESTIGATION

PRELIMINARY REPORT

OPERATOR:	Kenya School of Flying
AIRCRAFT TYPE/MANUFACTURER:	PA34-200T
YEAR OF MANUFACTURE:	1977
AIRCRAFT REGISTRATION:	5Y-JMK
AIRCRAFT SERIAL NUMBER:	34-7770384
DATE OF REGISTRATION:	12/05/2015
TYPE OF ENGINE:	2-CONTINENTAL MOTORS 0-360-EB (3)
DATE OF OCCURRENCE:	07/07/2019
TIME OF OCCURRENCE:	1532
LOCATION OF OCCURRENCE:	Orly Airpark
TYPE OF FLIGHT:	Training
NUMBER OF PERSONS ON BOARD:	2
INJURIES:	Nil
NATURE OF DAMAGE:	Slightly damaged
CATEGORY OF OCCURRENCE:	Incident
PIC'S FLYING EXPERIENCE:	217 hours

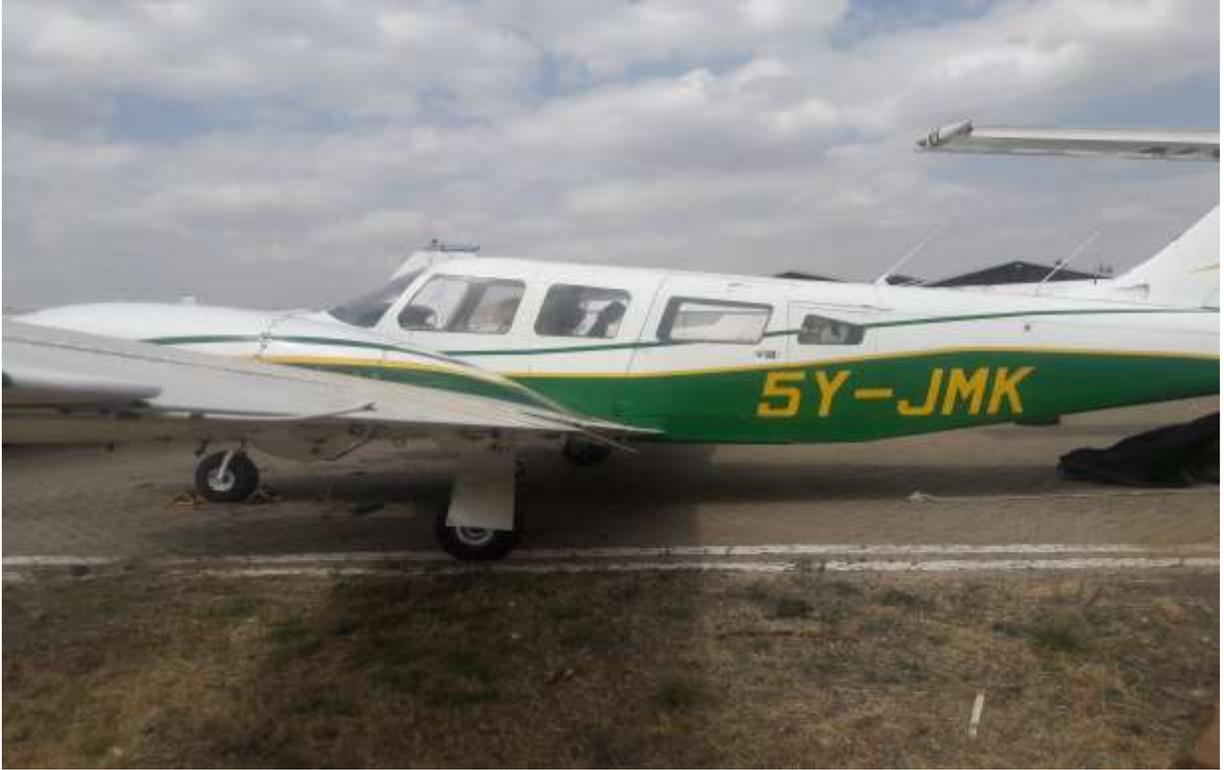
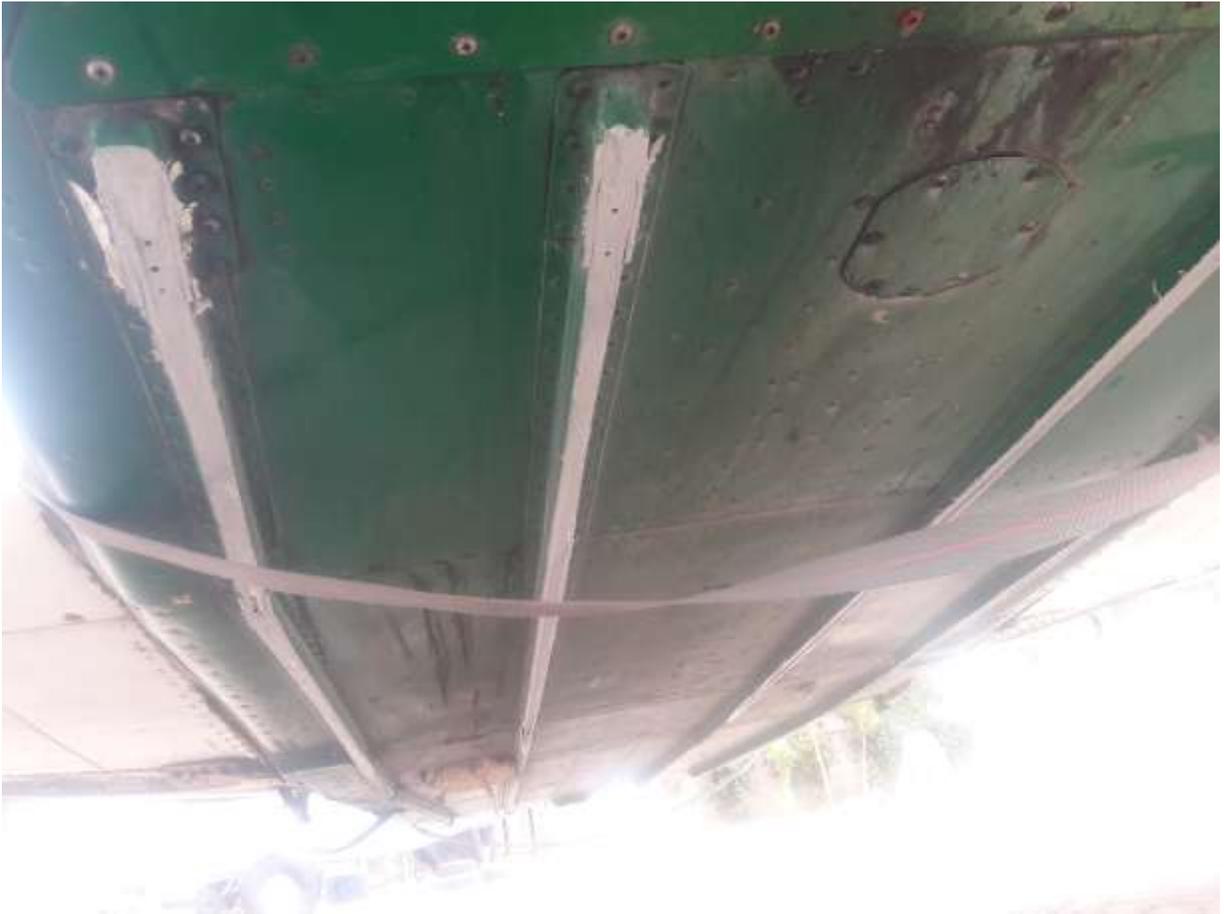
Both propellers struck the ground and got twisted at the ends. The lower fuselage belly got chaffed.
