**AIR ACCIDENT INVESTIGATION**

**PRELIMINARY REPORT**

OPERATOR:	Five Forty Aviation ltd
AIRCRAFT TYPE:	De Havilland DHC D8-314
AIRCRAFT MANUFACTURER:	De Havilland Aircraft of Canada Ltd.
YEAR OF MANUFACTURE:	TBA
AIRCRAFT REGISTRATION:	5Y - CHG
AIRCRAFT SERIAL NUMBER:	525
DATE OF REGISTRATION:	TBA
TYPE OF ENGINE:	PW123B, 2No.
DATE OF OCCURRENCE:	02 February, 2020
TIME OF OCCURRENCE:	1150
LOCATION OF OCCURRENCE:	Malindi Airport (HKML)
TYPE OF FLIGHT:	Commercial - Passenger
NUMBER OF PERSONS ON BOARD:	Crew – 3, Passengers - 10
INJURIES:	None
NATURE OF DAMAGE:	Minor
CLASS OF OCCURRENCE:	Incident (Ground)
PIC'S FLYING EXPERIENCE:	TBA

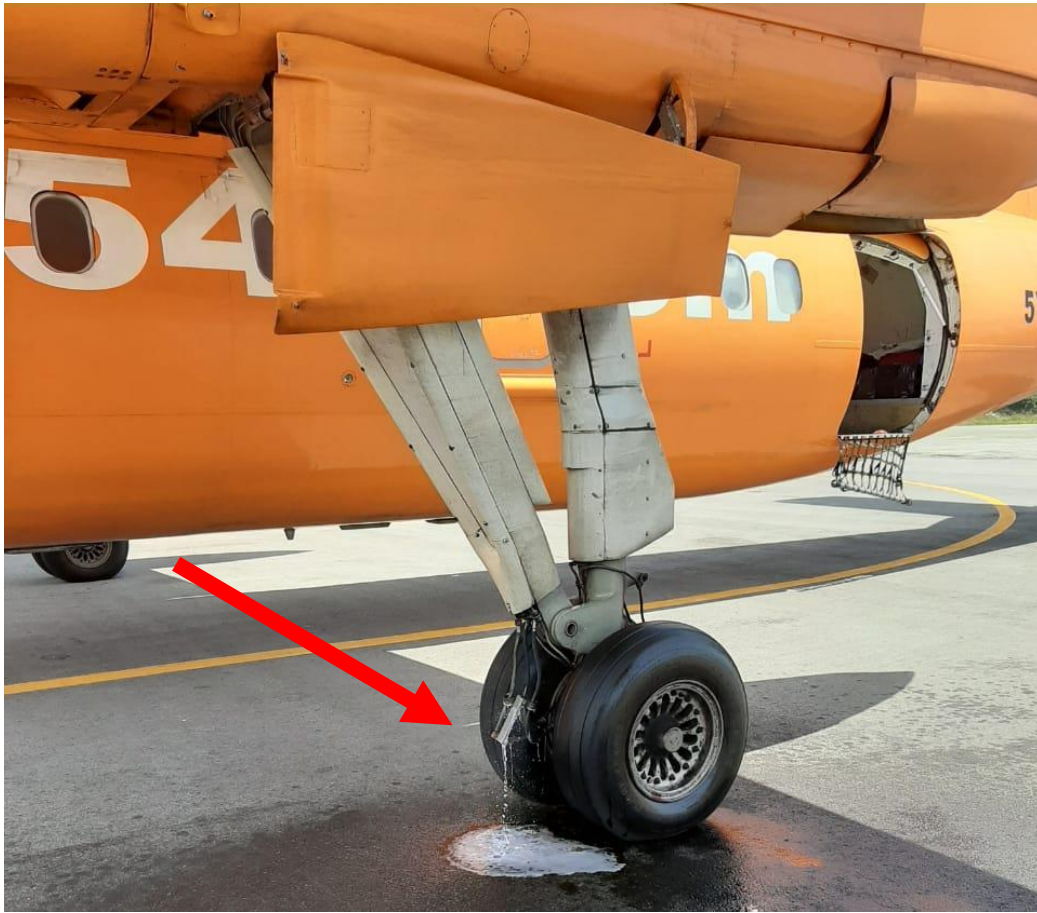
**1. 5Y-CGH parked at the apron area of Malindi airport: left main landing gear brakes hydraulic leak**

On touchdown, the number one hydraulic system line of the left main landing gear ruptured leading to loss of hydraulic pressure and hydraulic fluid. The crew proceeded to the apron area when the aircraft was parked. The airport's Aircraft Rescue and Firefighting engine was deployed and met the aircraft at the apron. All onboard disembarked from the parked aircraft safely.

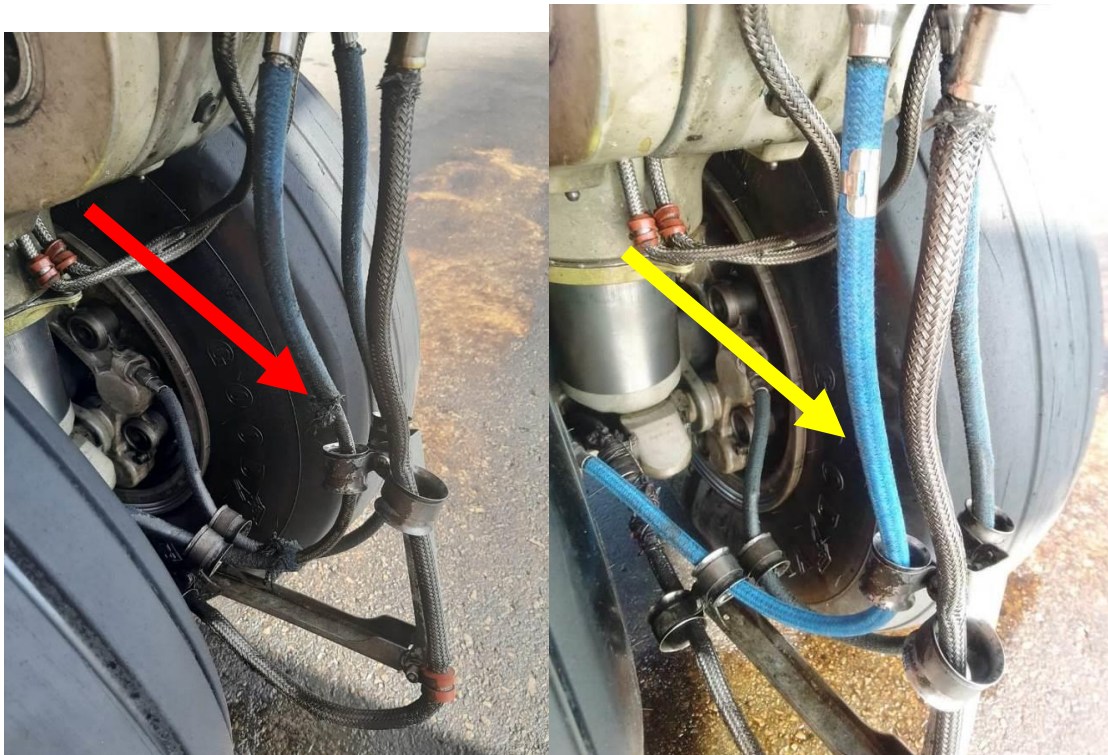
**2. Photos of the affected line and its replacement respectively.**

The operator's maintenance crew was flown in from Wilson airport (HKNW) in Nairobi on the same day to fix the snag. The leaking system was identified; the ruptured line which is a flexible hose assembly replaced with a serviceable one and secured in accordance with the relevant sections of the approved maintenance manual and current Kenya Civil Aviation Authority's (KCAA's) regulations.

Successful functional check was conducted and the aircraft released back to service vide a signed certificate of release to service.
