AIRCRAFT ACCIDENT INVESTIGATION DEPARTMENT

PRELIMINARY AIRCRAFT ACCIDENT REPORT 11/2020

REPORT ON THE CESSNA 172

REGISTRATION 5Y-KAS

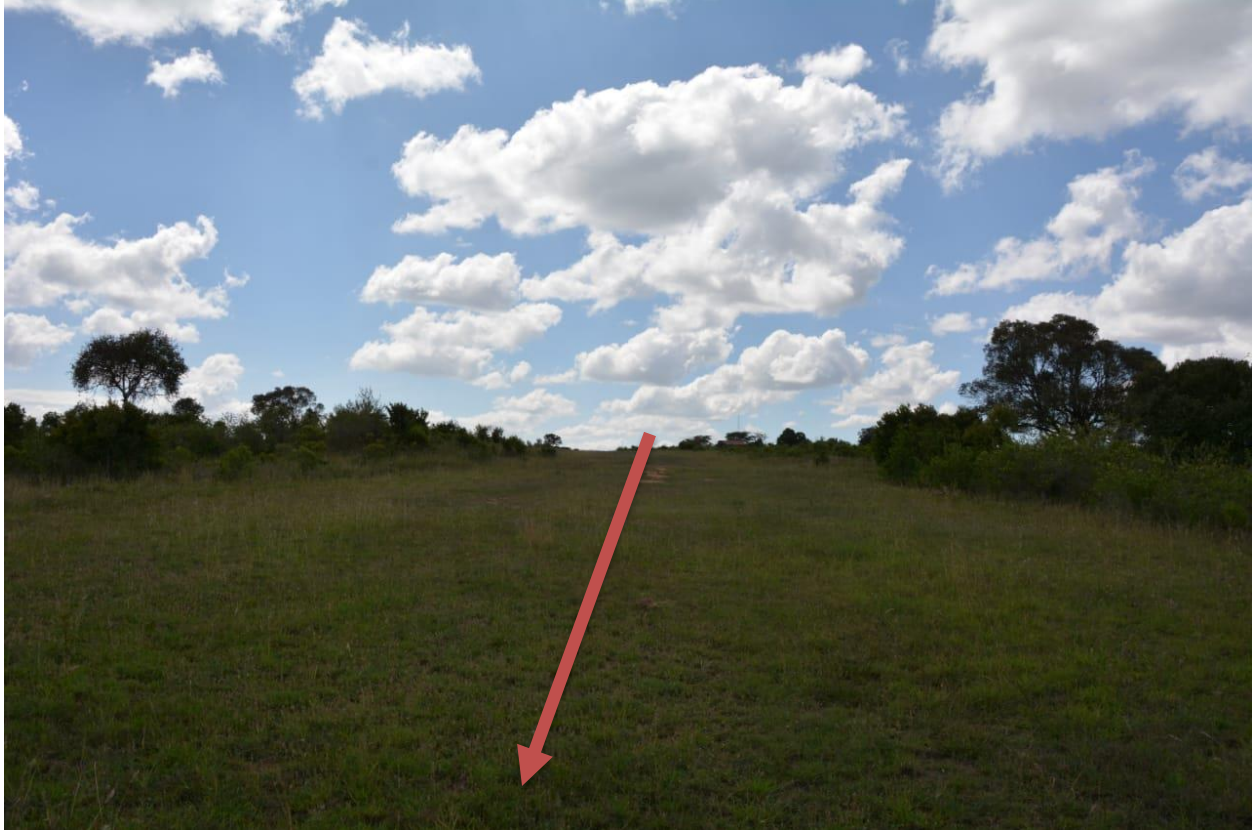
Figure 3: Photograph showing the pilot’s landing direction at Laragai airstrip

Laragai airstrip is a grass runway located at N 00°16’11” E 37°19’44”. It is 45 minute flight from Nairobi Wilson. It has two runways 18/36 and 36/18. It measures 1200m length and 25m width. it has a common northerly wind flow direction. Most landingS and take-off is from the south i.e on runway 36.

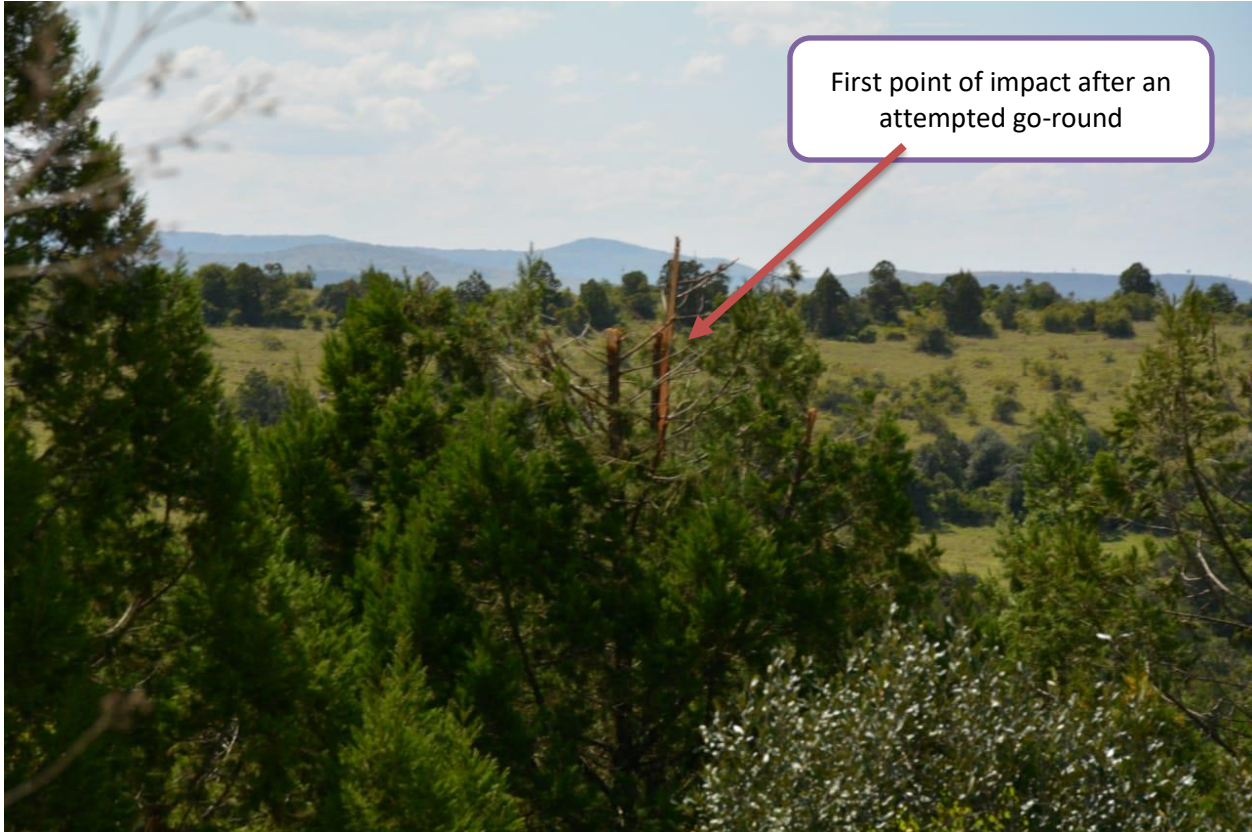
The flight was uneventful as he approached Laragai airstrip at 12.40pm from the north. Indicated airspeed on approach was 65 knots and the wind was varying from north to east. The aircraft floated for some time before touching down however he realised that he was rolling too fast and running out of the runway and elected to go around to attempt the landing again, unfortunately he was unable to gain sufficient speed and height to clear a tree at the end of the runway which he struck.

Figure 4: Photograph showing first point of impact with a tree after attempted go-round

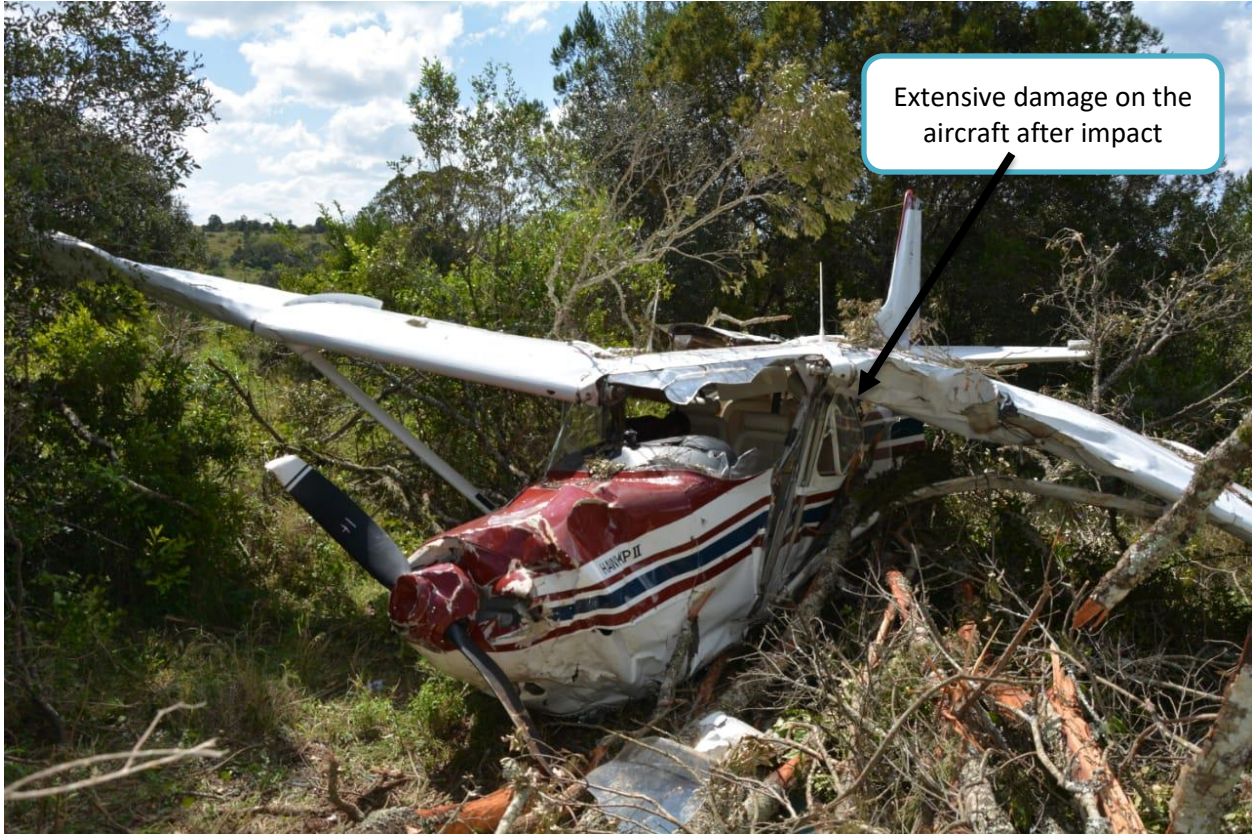
This then started a series of events where the aircraft skewed sideways as a result of the impact from the first tree and the wings struck several other trees, twisting the aircraft around and it eventually came to a standstill facing the opposite direction from the landing and pointing up the slope. The pilot was still conscious the entire time and tried to control the aircraft as much as possible but there was little he could do to steer the plane except try and cushion the impact as much as possible.

Figure 5: Location of the wreckage of the aircraft after impact

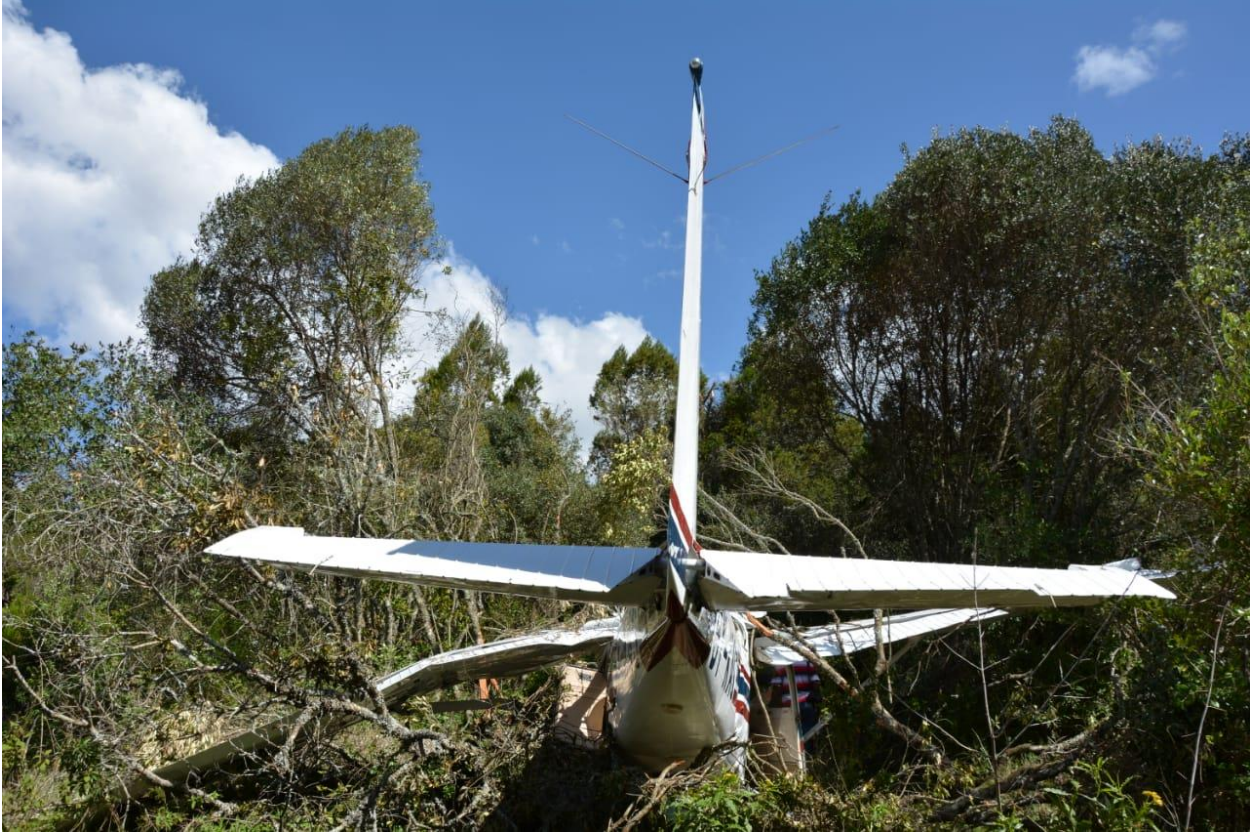
There was extensive damage on the aircraft except the tail. The left wing got broken and extensively dented. The interior part of the aircraft was relatively intact. Both passenger doors also got broken. The front wheel collapsed on impact and both landing gears remained intact.

Figure 6: Photograph showing aircraft empennage section after impact

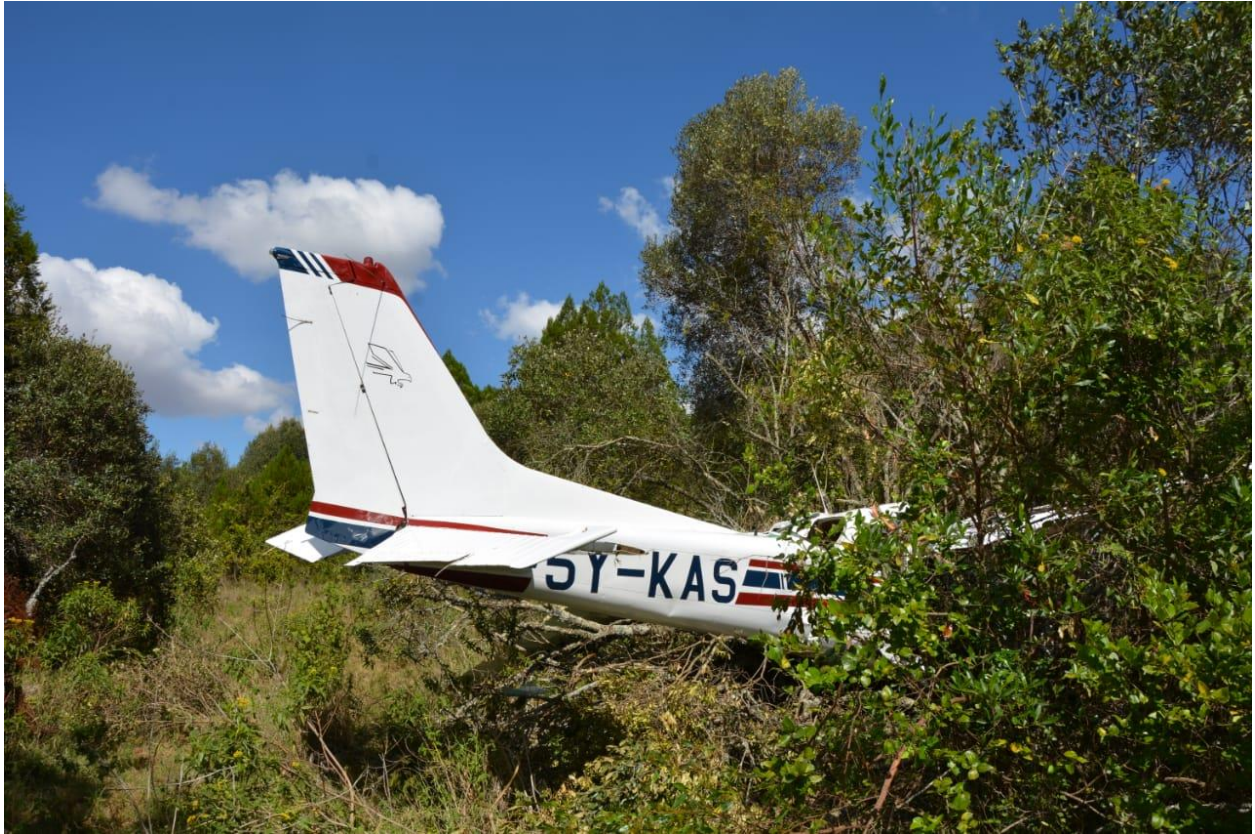
Figure 7: Photograph showing the tail section of the aircraft after impact

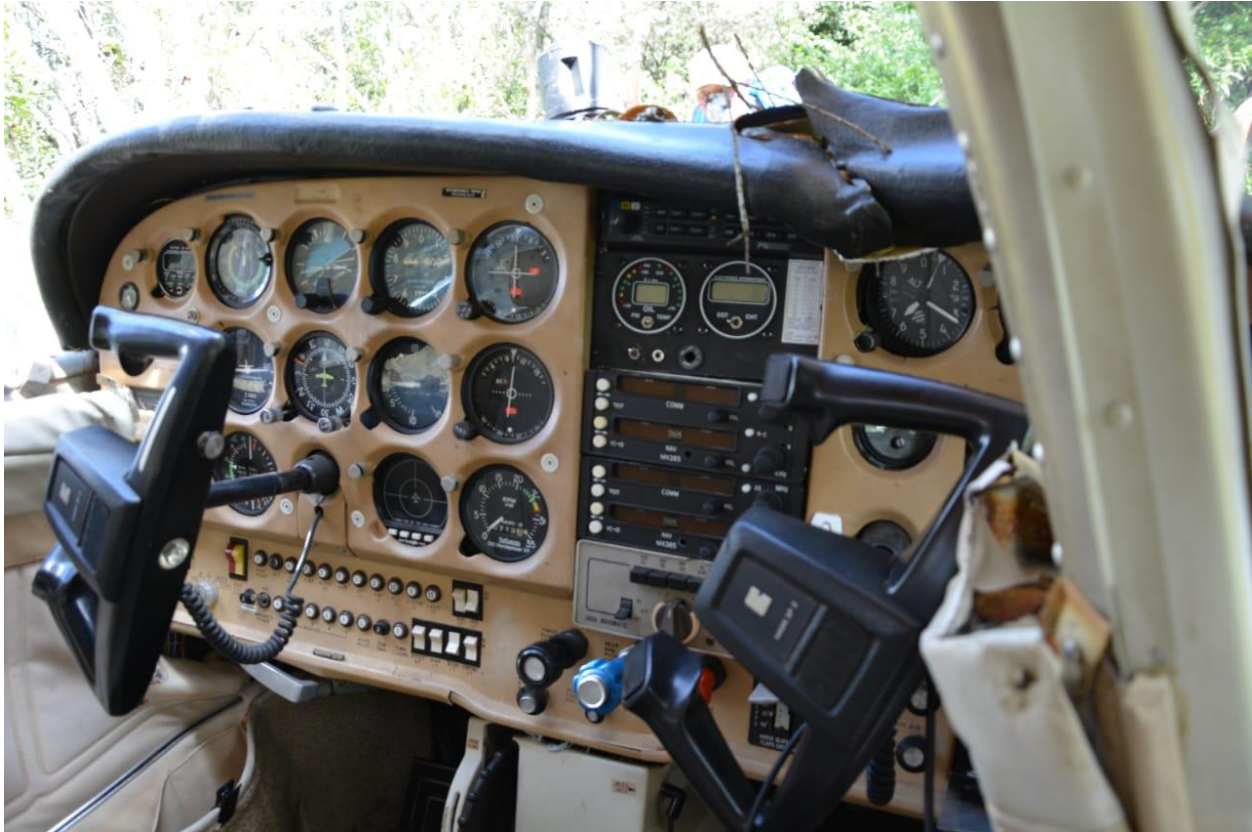
Figure 8: Photograph showing the avionics section of the aircraft after impact
