**AIRCRAFT ACCIDENT INVESTIGATION**

**PRELIMINARY AIRCRAFT ACCIDENT REPORT TO**

**BEECHCRAFT KINGAIR 200**

**REGISTRATION 5Y-NJS AT**

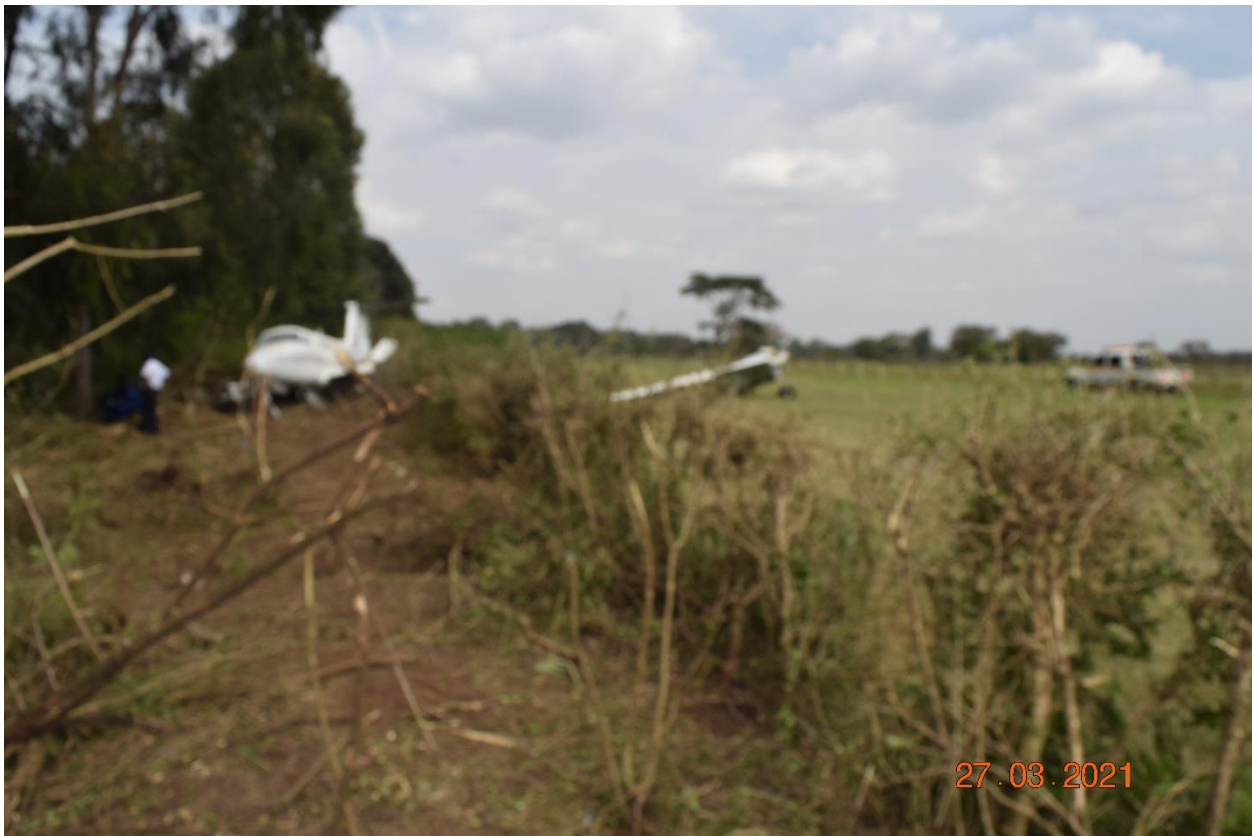
**Figure 1:** Photograph showing the accident site

aircraft attained flight level 250 42NM from Eldoret VOR. The flight was then cleared to fly direct to GV VOR by Nairobi Area Control Centre. During descend to flight level 100 they encountered bad weather whereby the wings developed heavy icing. The Captain deployed de-icing systems on the wings but the problem persisted. The situation prompted the Captain to request Wilson Control to descend to “Monstry fix” for landing at HKNW which was approved. As the flight continued descending the left engine went off. The Captain requested Wilson Tower for assistance. After 30 seconds, the right engine also went off. The Captain elected to make an emergency landing at Ngong Racecourse. On landing, the left wing collided with trees, broke-off and separated together with the left engine and the left main landing gear. The turned clockwise through 180° and faced the opposite direction. All three onboard escaped unhurt but the aircraft was destroyed.

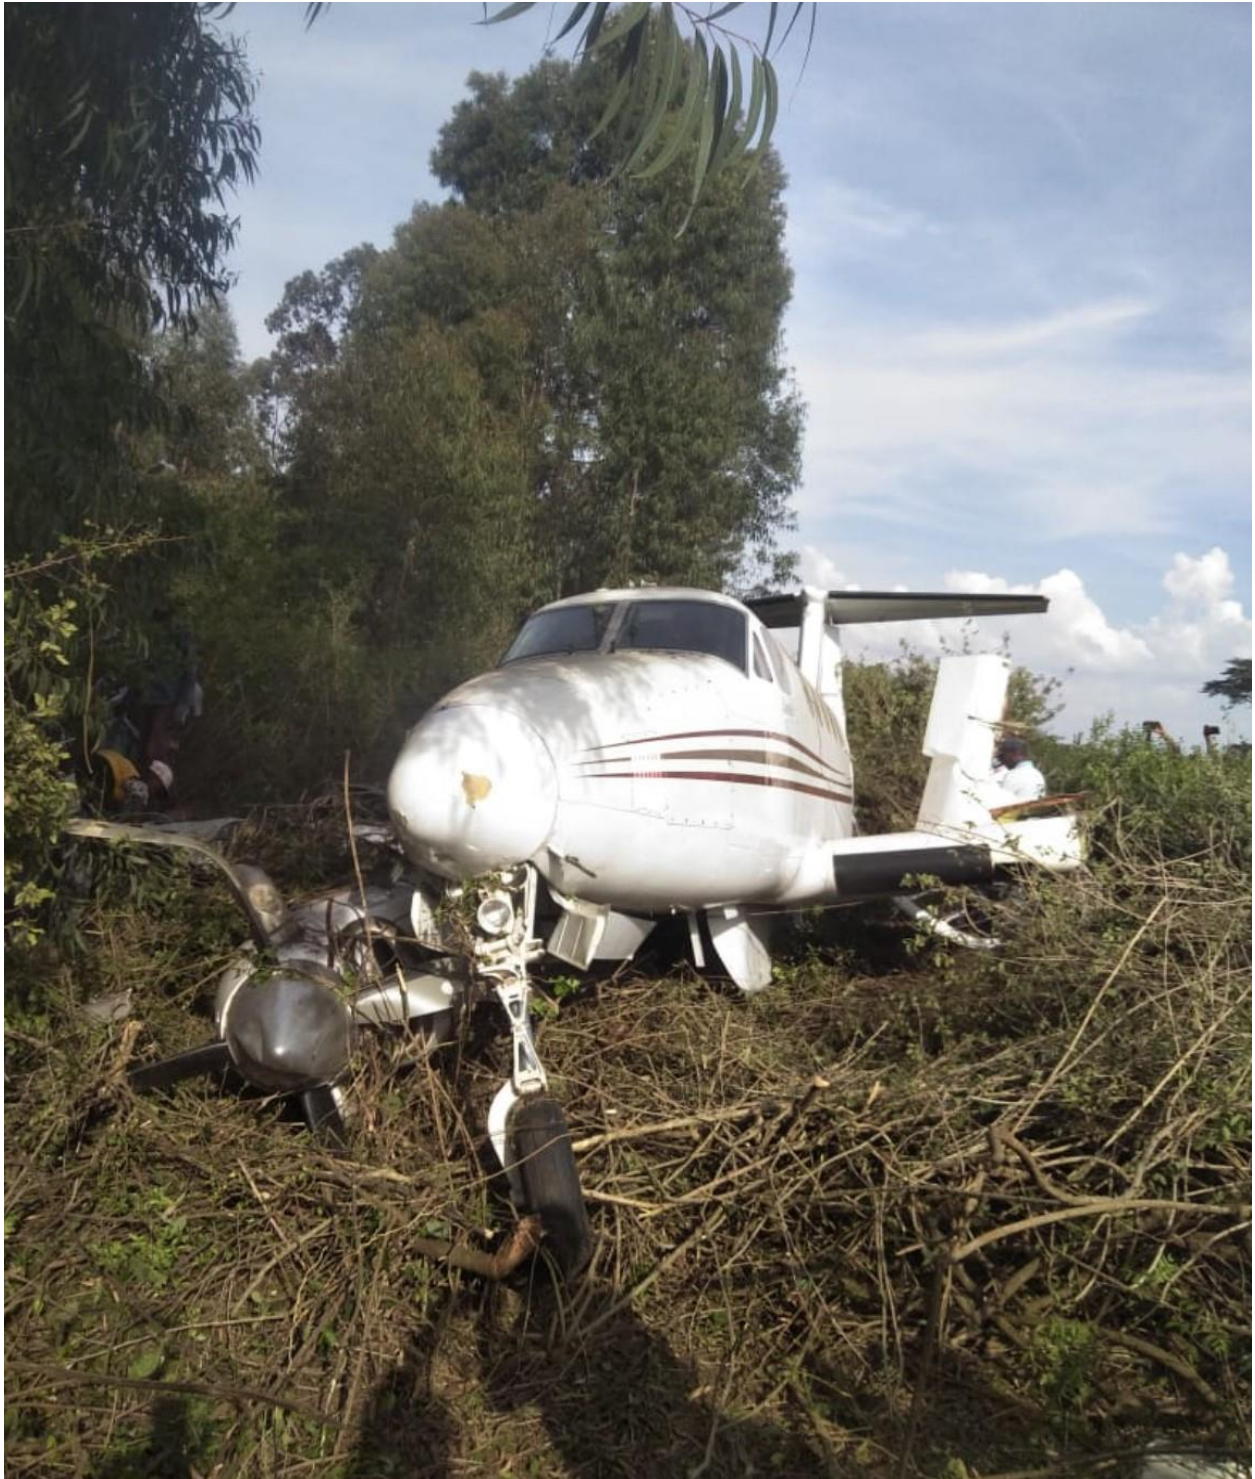
**Figure 4:** Photograph showing the accident aircraft on the accident site

On touch-down, the left wing collided with trees along the fence of horse racecourse after which it broke off and separated together the left engine and the left main landing gear. The aircraft went into 180° right-turn and stopped facing opposite direction. The right wing, engine and the left main landing gears got battered but remained attached to the main fuselage. The nose wheel got dented but remained attached to the assembly. The main fuselage got dented on several parts but remained intact. The cabin remained intact with no significant damage. The windscreen and the cabin windows remained intact and un-shattered.

The engine propeller blades got twisted but remained attached to main assembly on both engines. Few parts of fuselage broke and separated but remained within the accident site.

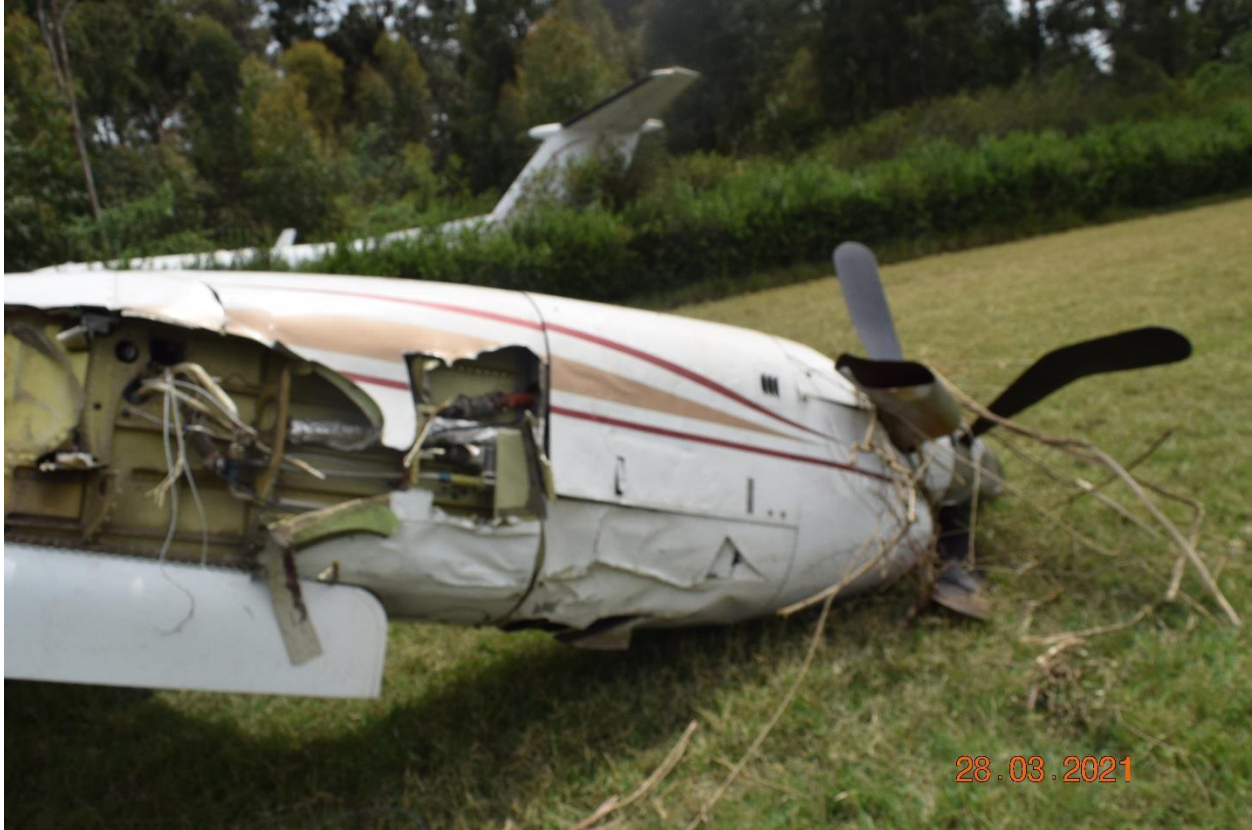
**Figure 5:** Photograph showing the left engine on the accident site
