**MINISTRY OF TRANSPORT AND INFRASTRUCTURE**  
**STATE DEPARTMENT OF TRANSPORT**  
**AIR ACCIDENT INVESTIGATION DIVISION**

**PRELIMINARY REPORT**

OPERATOR:	Skylink Flight Services Limited
AIRCRAFT TYPE/ MANUFACTURER:	Cessna 172K/ Cessna Aircraft Company
YEAR OF MANUFACTURE:	1969
AIRCRAFT REGISTRATION:	5Y-BWL
AIRCRAFT SERIAL NUMBER:	17257888
DATE OF REGISTRATION:	26 January 2009
NUMBER AND TYPE OF ENGINE:	One Lycoming (0-320-E2D)
DATE OF OCCURRENCE:	9 October 2013
TIME OF OCCURRENCE:	0618
LOCATION OF OCCURRENCE:	Nairobi National Park
TYPE OF FLIGHT:	Training
NUMBER OF PERSONS ON BOARD:	Two
INJURIES:	Fatal
NATURE OF DAMAGE:	Destroyed
CATEGORY OF OCCURRENCE:	Accident
INSTRUCTOR'S FLYING EXPERIENCE:	CPL: 700 hours

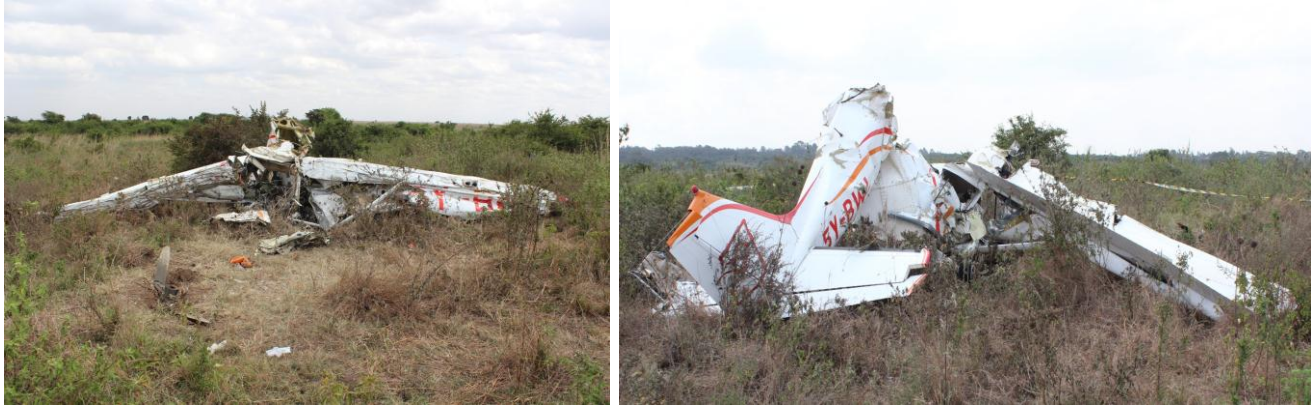
Accident Photos

The aircraft impacted a relatively flat terrain nose-first and the main wreckage came to rest 5 meters from the initial point of impact. Accident debris was distributed over a distance of 20 meters from the initial point of impact in the direction of 120° East of South East. The aircraft was destroyed as a result of the impact. There was no evidence of fire at the accident site. All the occupants sustained fatal injuries.
