**AIRCRAFT ACCIDENT INVESTIGATION DEPARTMENT**

**INVESTIGATION REPORT 01/02/2021**

**REPORT ON THE ACCIDENT TO AGUSTA WESTLAND  
AW119 MK II REGISTRATION 5Y-NPW OPERATED BY  
THE NATIONAL POLICE SERVICE AIR WING  
AT MERU, KENYA ON 13 JUNE 2020**

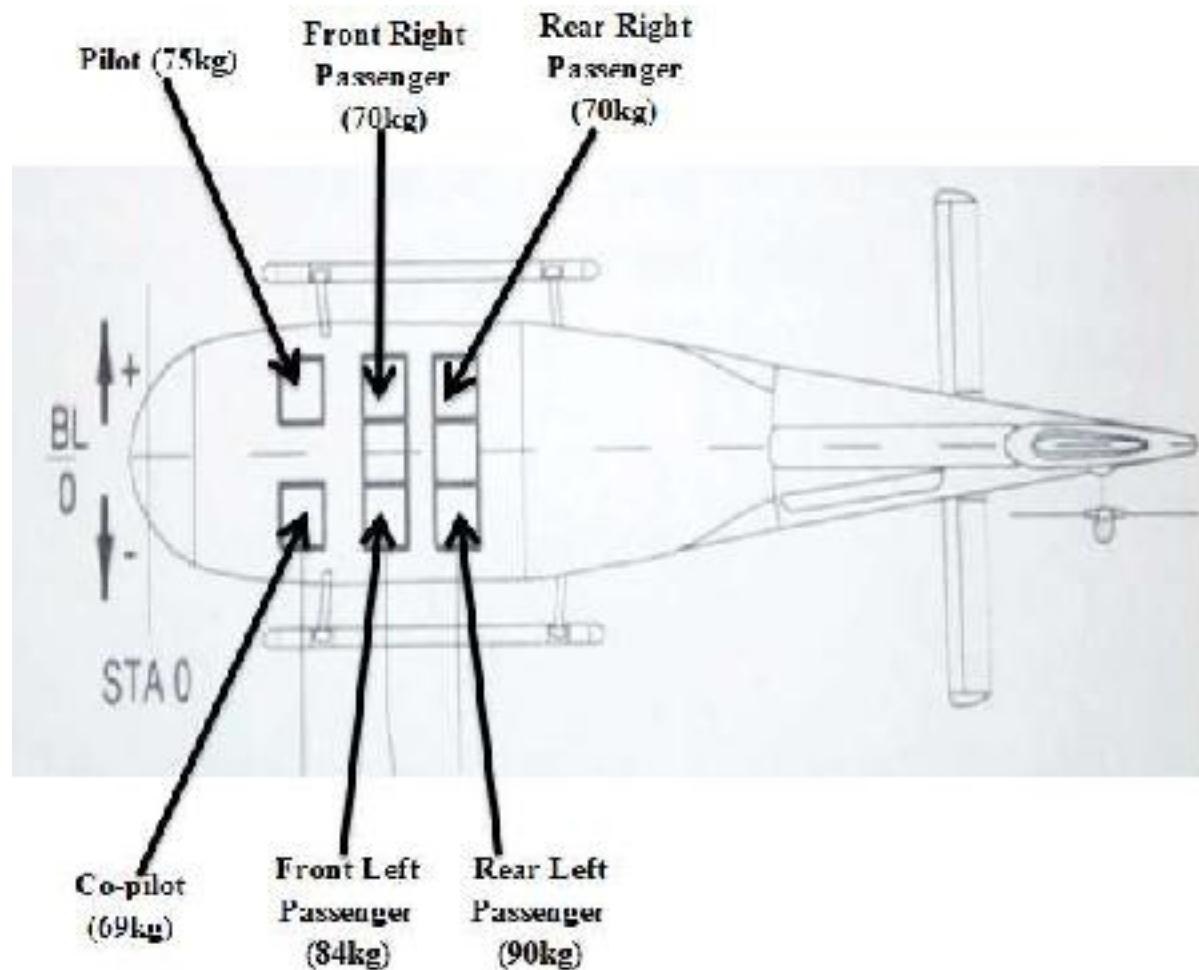
Figure 24: The seating configuration of the event flight

The investigation established that the aircraft weight and balance data was not prepared before the flight or before each leg of the flight. The helicopter took off from Wilson airport with three

occupants and full tanks of fuel before three more occupants embarked in Embu with no luggage.

The computation of weight and balance on take-off from Embu is as follows;

- i. The empty weight of the aircraft AW119 MK 11 was 1765.5 Kg;
- ii. The longitudinal and lateral arms for the empty weight were 3645mm and -3.06mm respectively. Figures obtained from Chart C in Section 6 of the Aircraft flight manual;

- v. The longitudinal (STA) and the lateral (BL) arm of the passengers obtained from figure 6-1 in Section 6 of the flight manual. The longitudinal arm of the Pilot and Copilot was 1585mm. The lateral arm of the Pilot was 350mm while that of the Copilot was -325mm. The longitudinal arm of the front passengers was 2455mm and their lateral arms were 430 mm for the right seat and -430 mm for the left seat. The longitudinal arm of the back passengers was 3200mm and their lateral arms were 430 mm for the right seat and -430 mm for the left seat.
