AIR ACCIDENT INVESTIGATION

FACTUAL INCIDENT REPORT

5Y-BZK

CIVIL AIRCRAFT INCIDENT REPORT

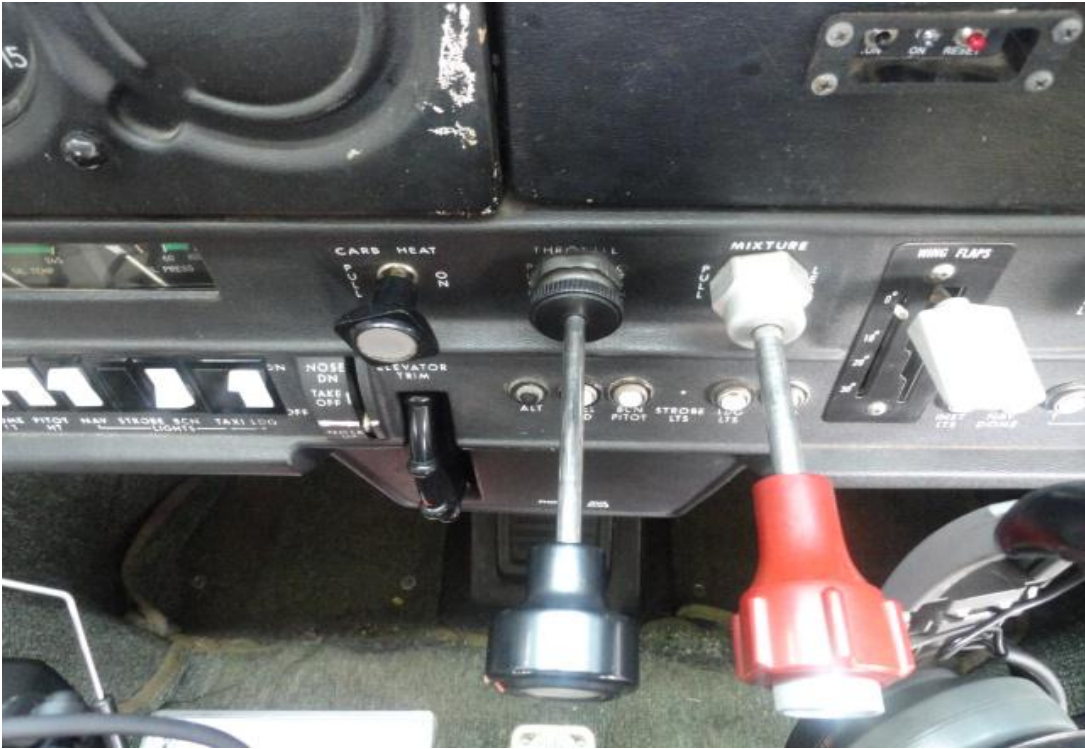
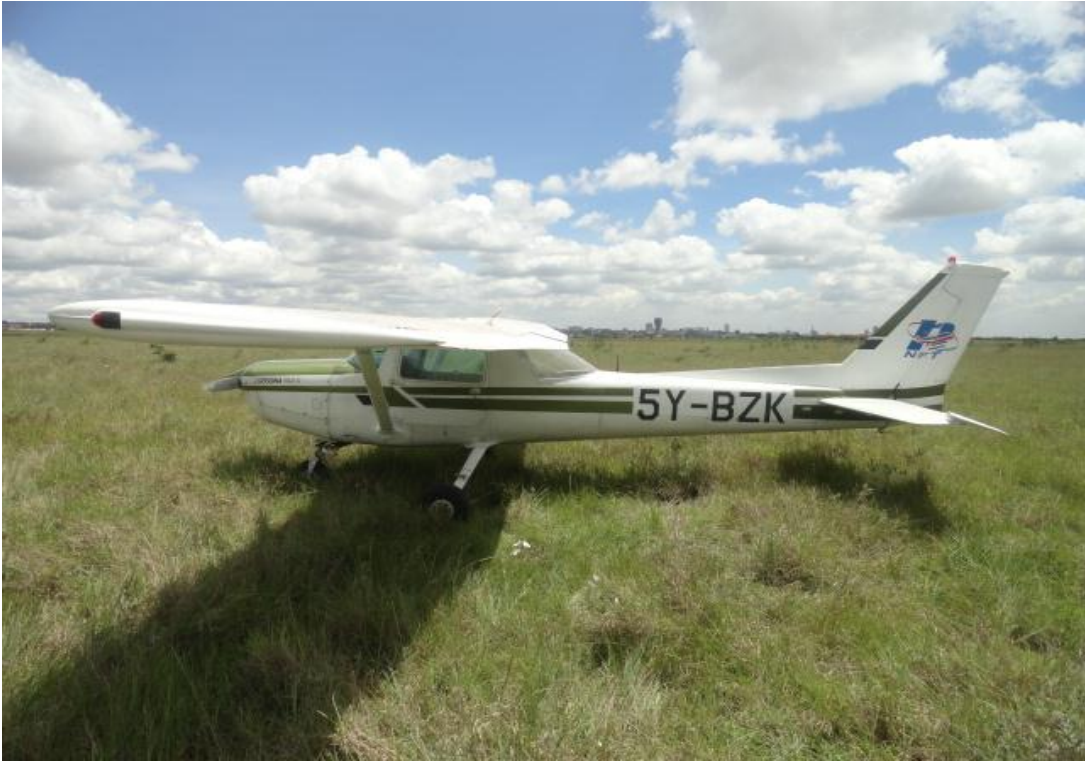
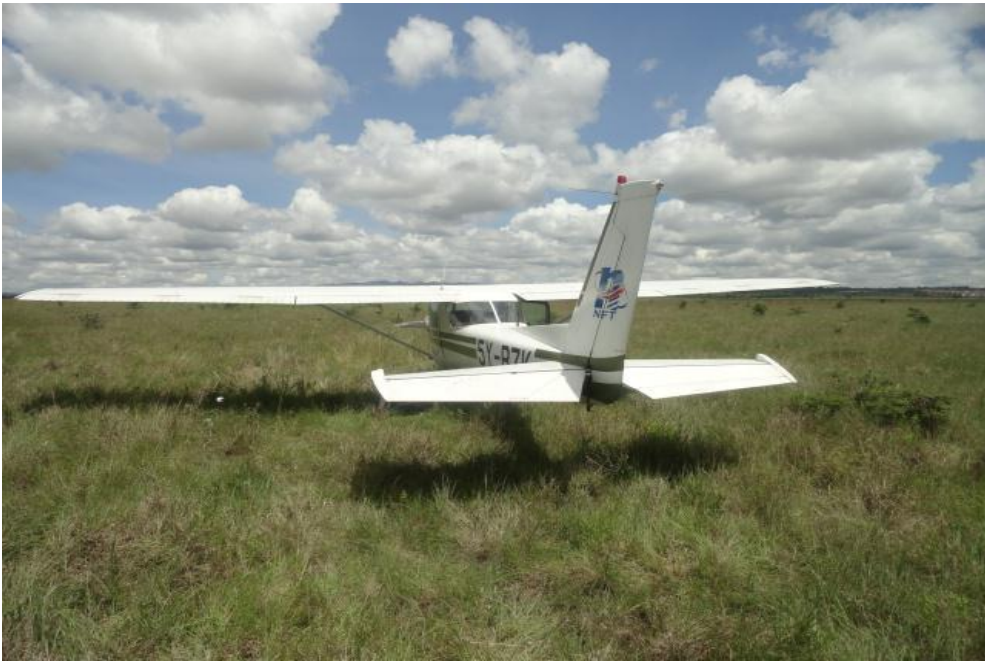
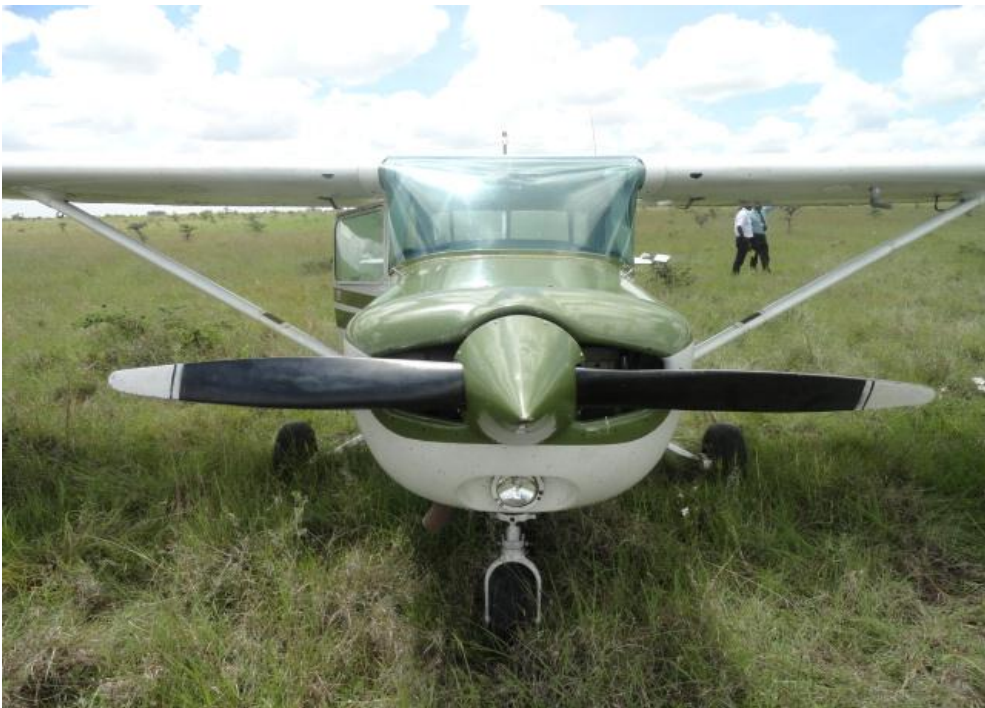
Appendix III - Photographs

The aircraft did not sustain any visible damage as a result of this incident.

The aircraft structure remained generally intact after the incident with no resultant visible damage. After the forced landing, the aircraft came to rest approximately 1670 meters from the threshold of runway 32 facing a
