AIRCRAFT ACCIDENT INVESTIGATION

**PRELIMINARY ACCIDENT REPORT 5Y-CAC
05.06.2018**

**CESSNA CARAVAN 208B
THE ABERDARES RANGE, NJAMBINI**

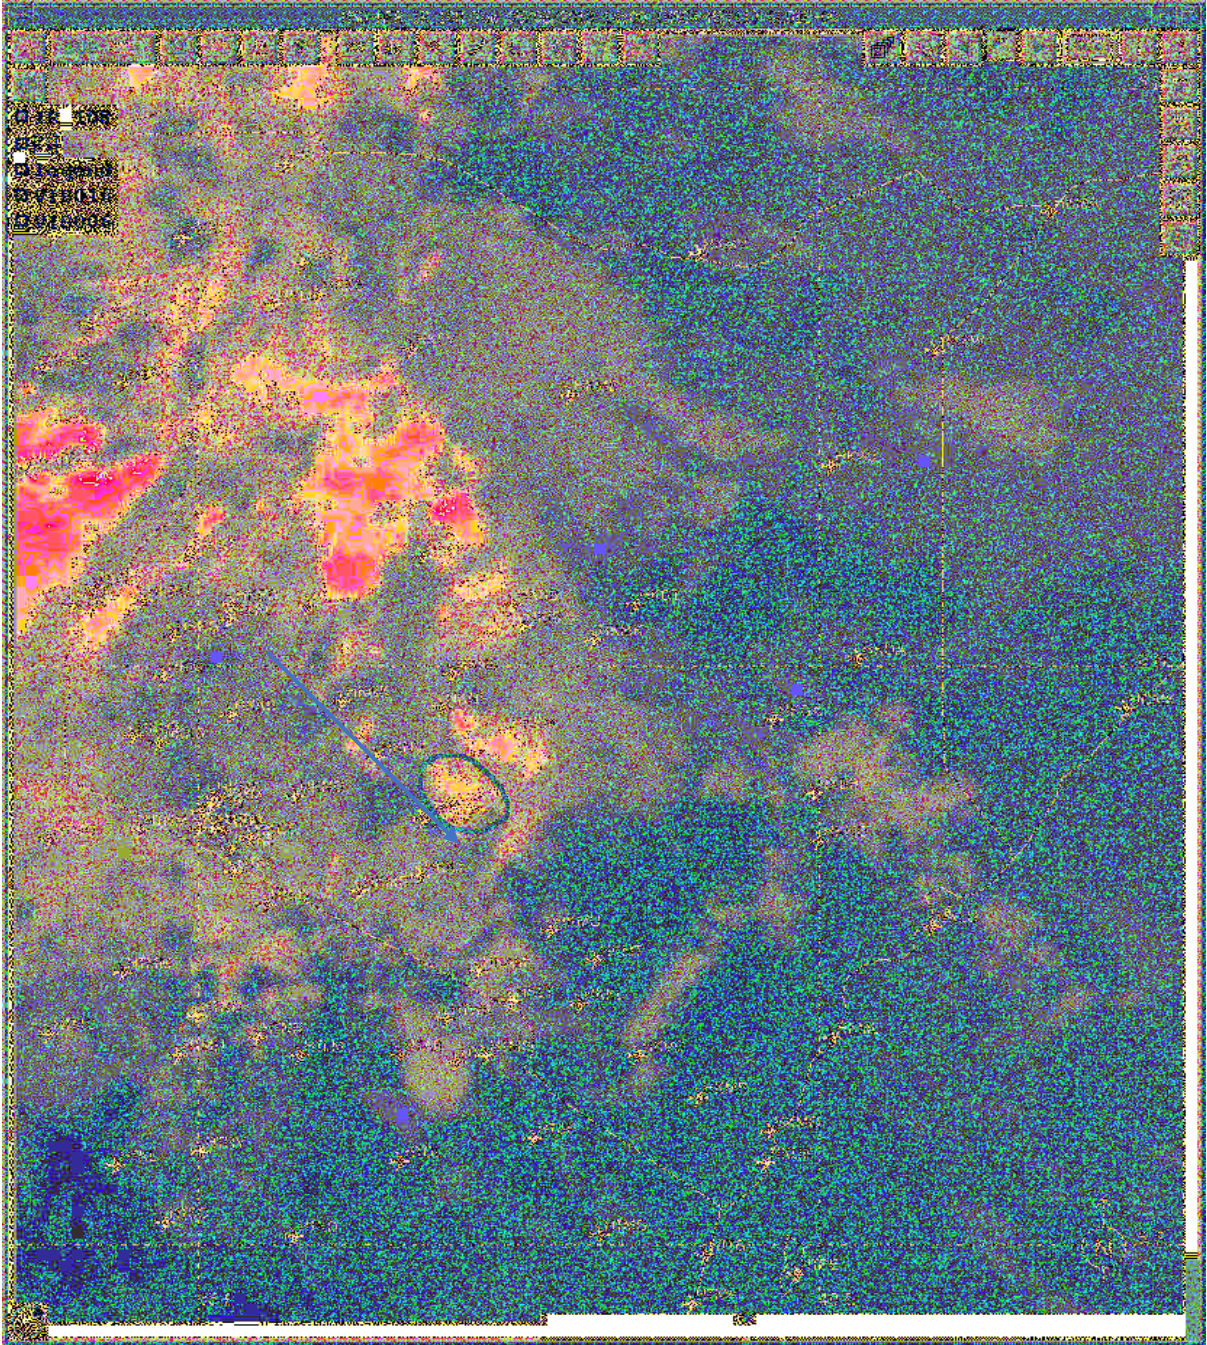
The Graphical Area of the Satellite image for 1700 local time indicated that the Aberdare region was under the influence of a trough of warm air aloft. The system featured overcast low-level clouds.

Figure 3: Satellite Image at 05/06/2018: 1700 local time (courtesy of Meteorological Department of Kenya)

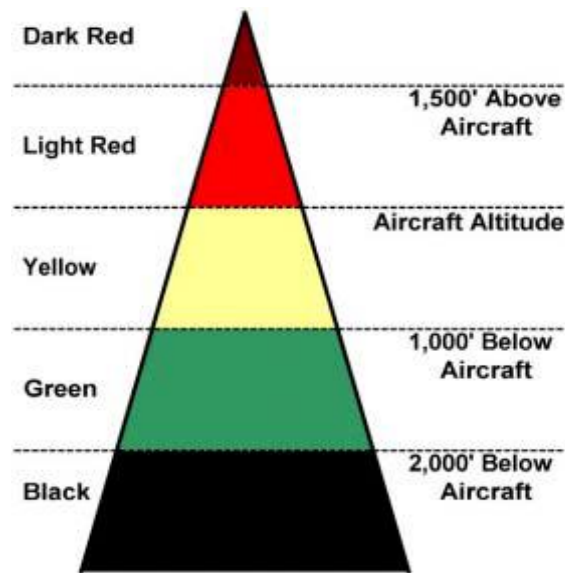
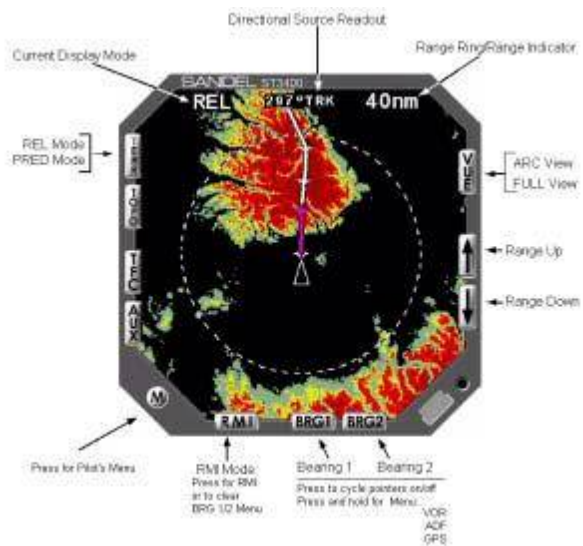
During enroute flight (not on approach to a runway or airport) the nominal color coding is:
 Dark Red: Greater than 1500' **above** the aircraft
 Light Red: Within 100' of the aircraft to 1500' **above** the aircraft
 Yellow: Between 1000' and 100' separation below the aircraft
 Green: Between 2000' and 1000' separation below the aircraft
 Black: Greater than 2000' separation below the aircraft

Figure 3: Representation of color coding and multi-function display of Sandel.

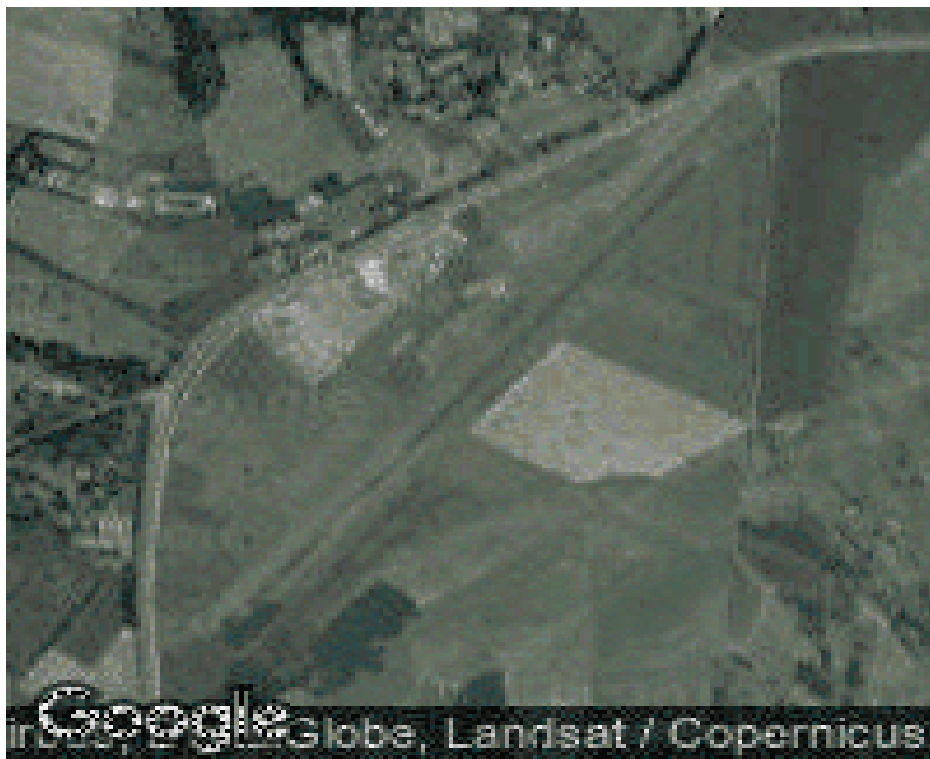
Figure 4: Google map showing HKKT aerodrome
