AIRCRAFT ACCIDENT INVESTIGATION DEPARTMENT

PRELIMINARY INVESTIGATION REPORT

**A SERIOUS INCIDENT TO THE AIRCRAFT 5Y- MMG, CESSNA 172 RG
ON 01 NOVEMBER 2021 AT LAMU MANDA AIRSTRIP, LAMU
COUNTY**

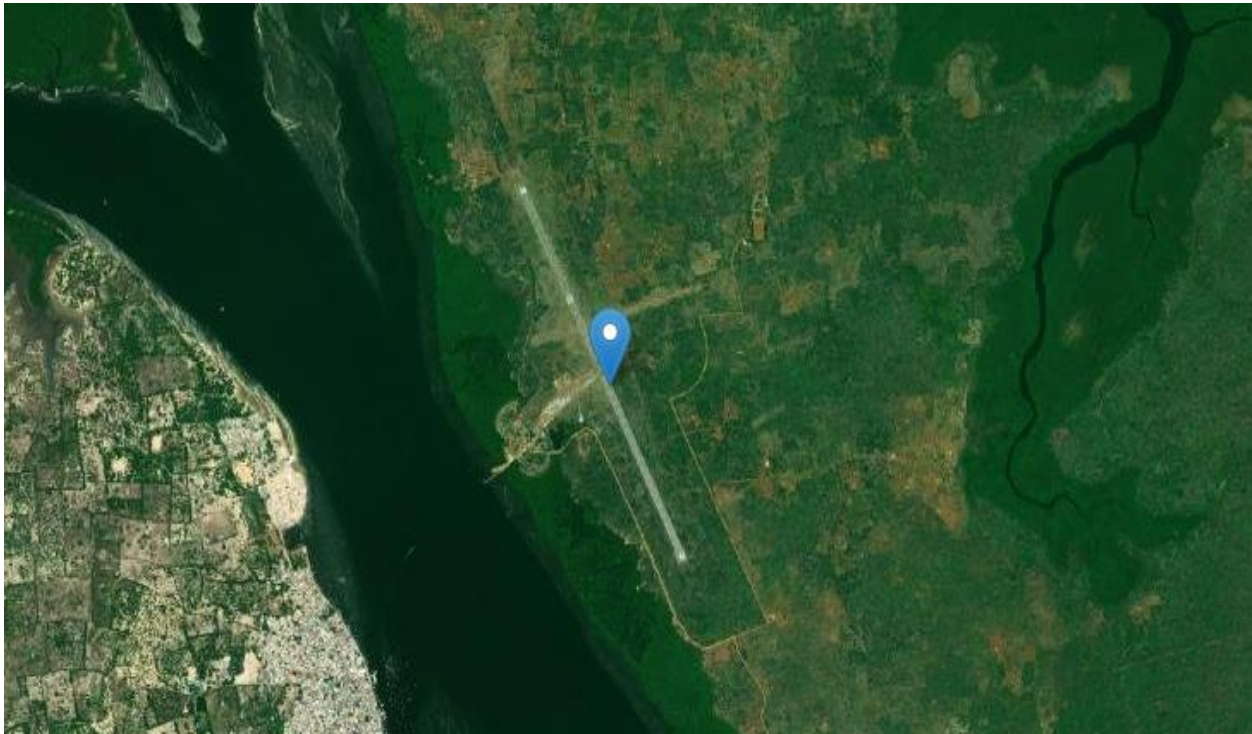
Figure 6: Aerial View of the Aerodrome

The airport serves Lamu Archipelago and is situated at 6 meters (20 ft.) above sea level. The airport has two runways, the first runway (15/33) is paved with asphalt and measures 6,330 feet (1,930 m) in length and 100 feet (30 m) in width. The second runway (08/26) is unpaved and is 3,054 feet (931 m) long and 46 feet (14 m) wide. At the time of the incident runway, (15/33) was in use. (See Figure 2).
