MINISTRY OF TRANSPORT, INFRASTRUCTURE, HOUSING,  
URBAN DEVELOPMENT AND PUBLIC WORKS  
STATE DEPARTMENT FOR TRANSPORT  
**AIRCRAFT ACCIDENT INVESTIGATION DEPARTMENT**

INVESTIGATION REPORT No. 01/08/2021

PRELIMINARY INVESTIGATION REPORT OF AN OCCURRENCE  
INVOLVING A DHC-2 BEAVER MK1 VIKING AIRCRAFT  
REGISTRATION 5Y-BCL ON 12 JULY 2021 AT KOSOVO AREA  
OF NDABIBI NAIVASHA IN NAKURU COUNTY

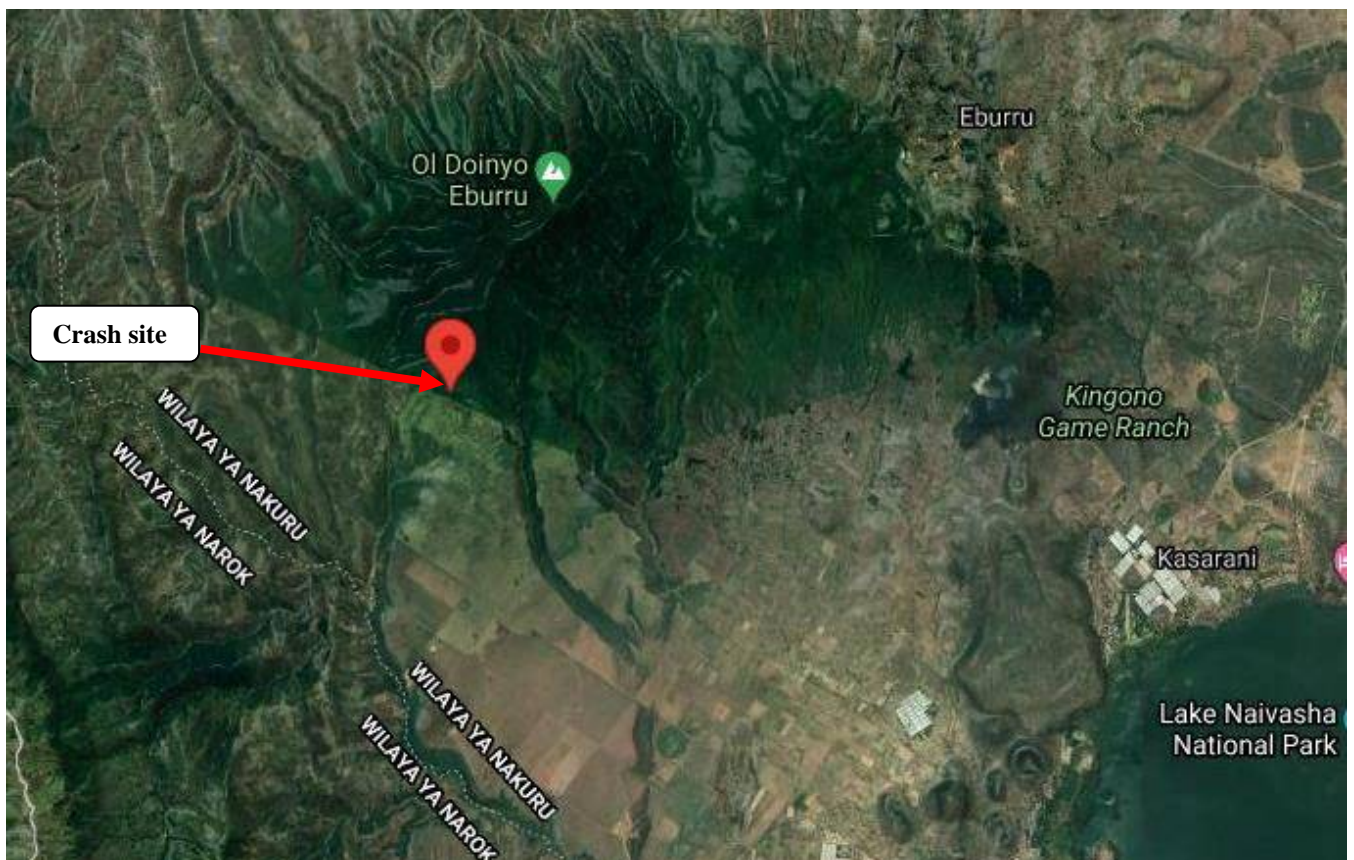
The accident site coordinates are 0° 40' 51''S, 36° 10' 06''E, at elevation 7,983 feet above mean sea level (AMSL).

**FIGURE No. 1 – Aerial View of crash site (source: Google earth, with AAID annotations)**

The aircraft struck a tree at a height of 8m leaving behind a part of the pesticide tank and moved forward 27m to impact the ground where the left wing was located. At a further 1.1m, the burnt engine and the

propeller were found dislodged from the fuselage. The propeller blades were bent and exhibited rotational damage. The cockpit, all instruments and the fuselage were consumed by fire. The tail plane was burnt and at a further 9m, the right wing was located. Its pesticide tank was damaged. Two sets were recovered burnt and damaged. The entire crash site area measured 18m long by 9m wide.

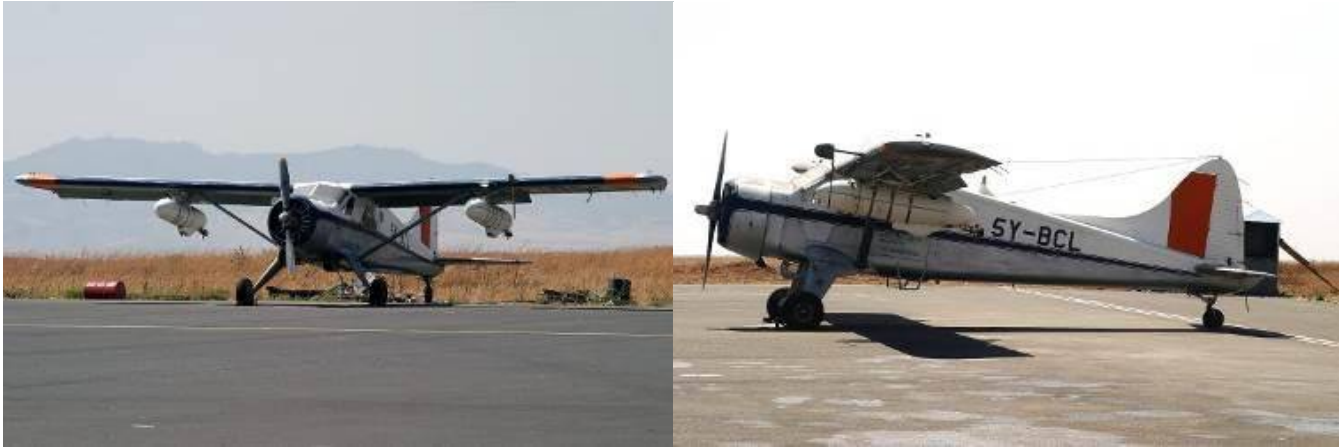
*FIGURE No. 5 – A photo of 5Y-BCL prior to the accident (photo, courtesy of the operator)*
