AIRCRAFT ACCIDENT INVESTIGATION DEPARTMENT

PRELIMINARY ACCIDENT REPORT TO

ROBINSON R44 HELICOPTER, 5Y-MEP

ELDAMAT-MELILI, NAROK COUNTY

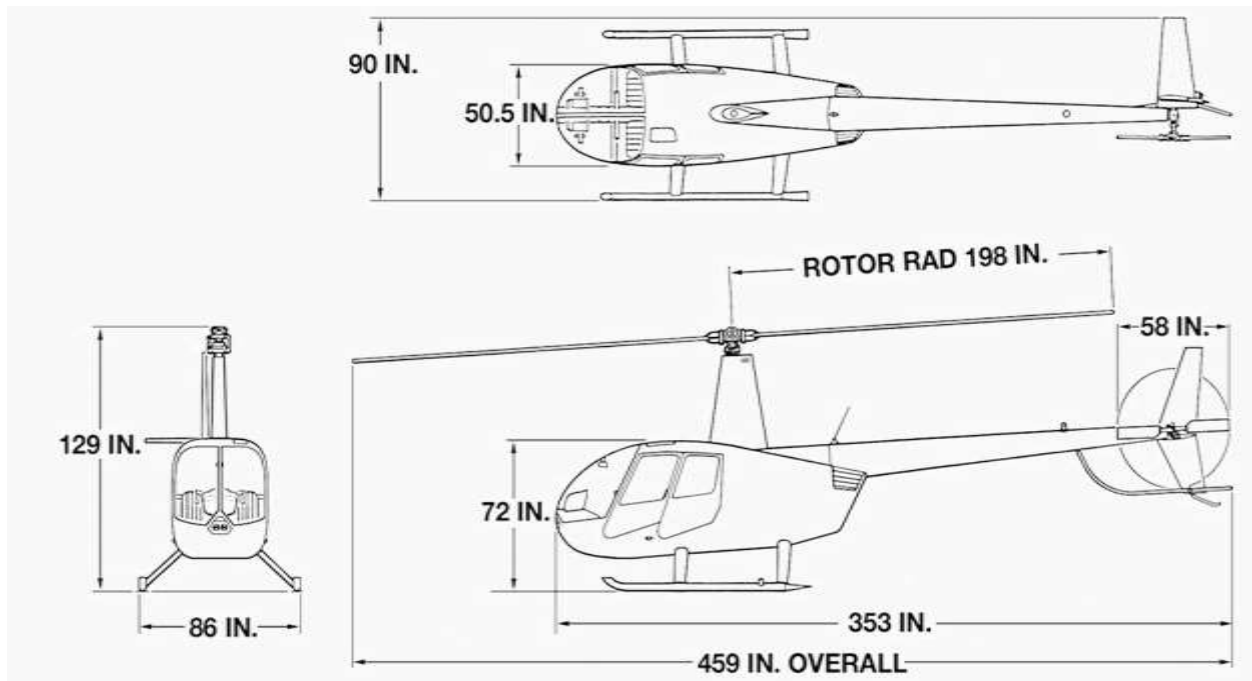
Figure 4: The Helicopter Dimensions

Damage to the helicopter as a result of the impact was as follows (see Figure 4).

- (a) The left skid was substantially damaged.
- (b) The main rotor blades remained attached to the helicopter but were significantly bent and twisted.
- (c) Both blades of the tail rotor were intact although detached from the tail boom.
- (d) The tail boom was severely fractured and detached from the main wreckage.
