AIRCRAFT ACCIDENT INVESTIGATION

PRELIMINARY REPORT TO
SILVERSTONE AIR SERVICES LIMITED
FOKKER 27 MK 050,
5Y-IZO
WILSON AIRPORT, KENYA
ON 11 OCTOBER, 2019

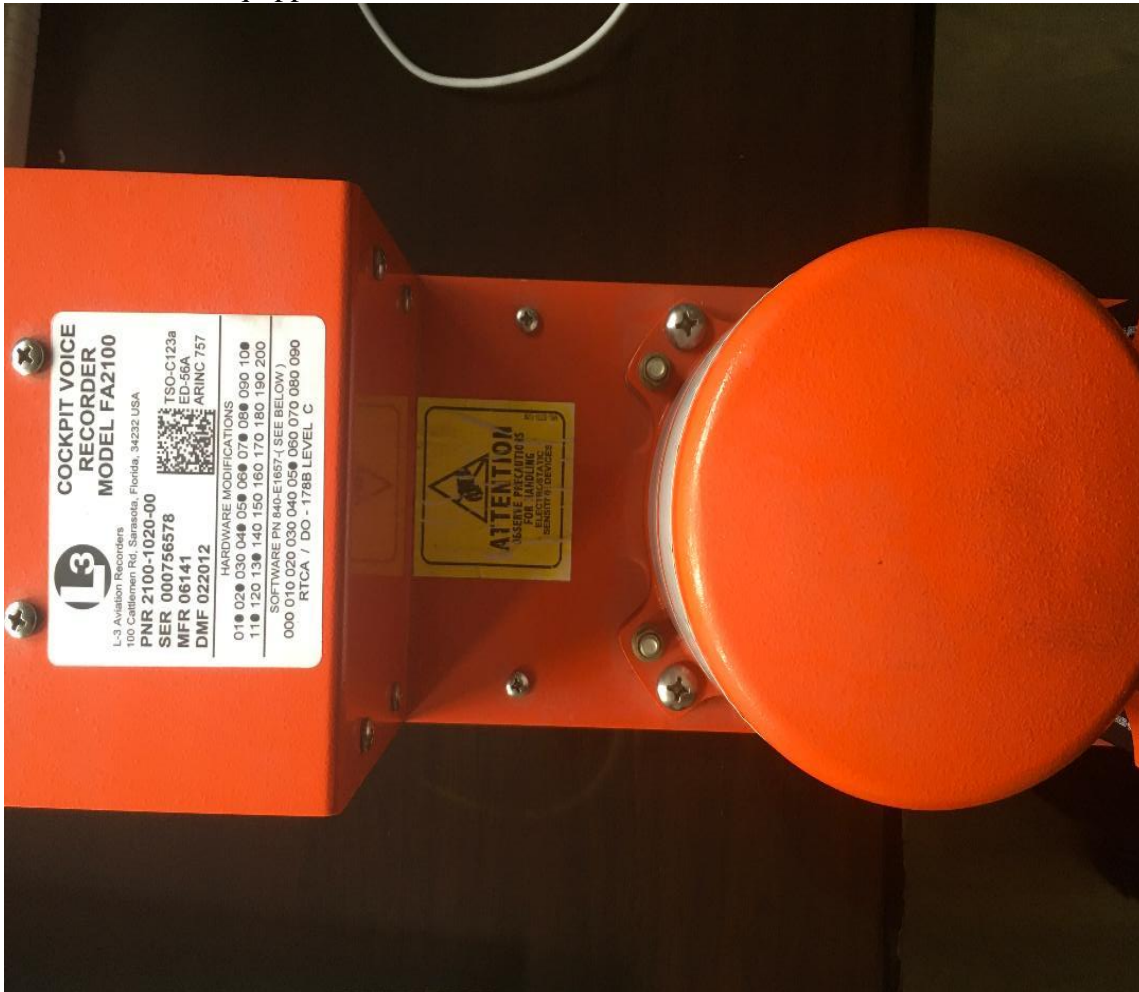
Figure 9: The Fairchild Model FA2100 CVR

The aircraft was equipped with a Fairchild Model FA2100

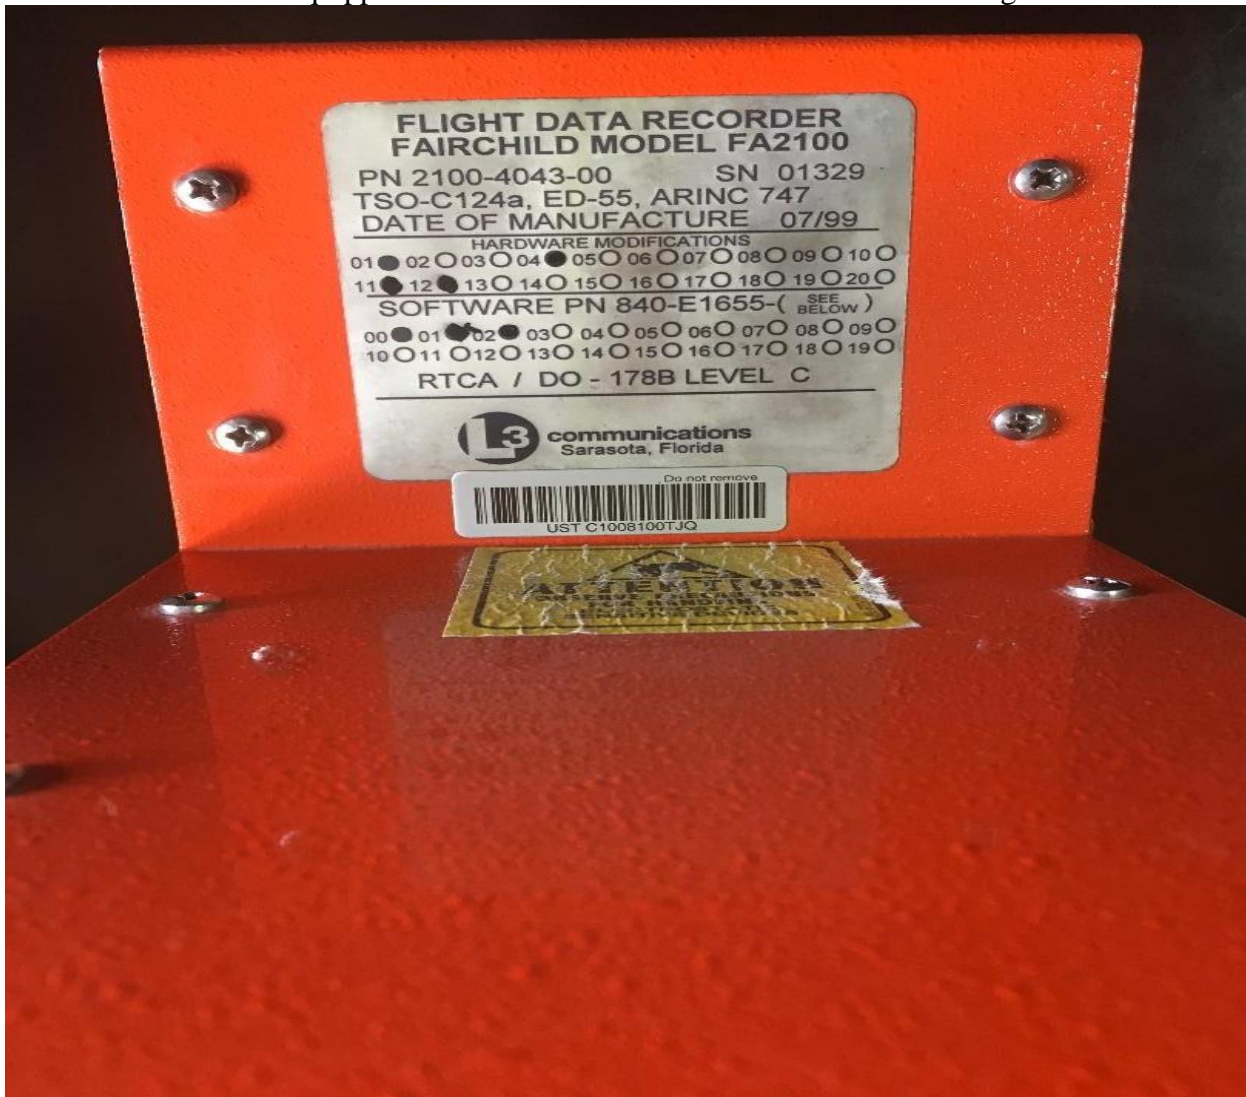
Figure 10: The Fairchild Model FA2100 FDR

The aircraft was equipped with a Fairchild Model FA2100 Flight Data Recorder.
