MINISTRY OF TRANSPORT AND INFRASTRUCTURE

AIR ACCIDENT INVESTIGATION DEPARTMENT

PRELIMINARY REPORT

OPERATOR:	OLDONYO LARO AVIATION
AIRCRAFT TYPE:	CESSNA U206F
MANUFACTURER:	CESSNA AIRCRAFT COMPANY
YEAR OF MANUFACTURE:	1978
AIRCRAFT REGISTRATION:	5Y-BPL
AIRCRAFT SERIAL NUMBER:	U206-04203
DATE OF REGISTRATION:	13 APRIL 2011
TYPE OF ENGINE:	TCM IO-550L-23B
DATE OF INCIDENT:	17 JUNE 2013
TIME OF ACCIDENT:	1035Z (1:35PM)
LOCATION OF ACCIDENT:	EWASO AIRSTRIP
TYPE OF FLIGHT:	PRIVATE
NUMBER OF PERSONS ON BOARD:	4 (Pilot and Pax-3)
INJURIES:	4
NATURE OF DAMAGE:	AIRCRAFT DESTROYED
CAPTAIN'S FLYING EXPERIENCE:	CPL over 800 HRS

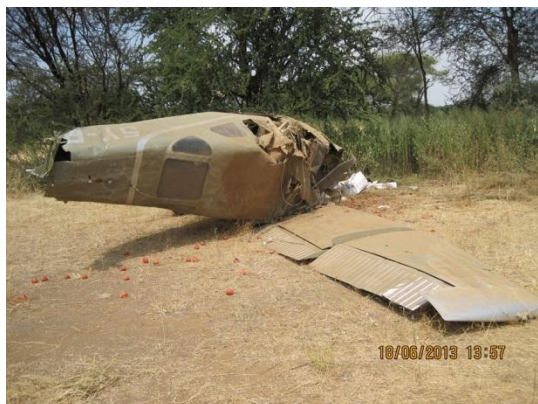
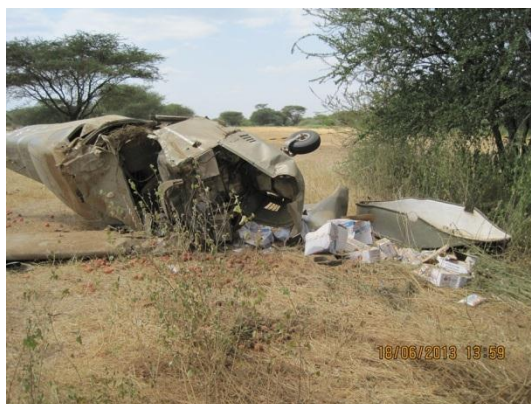
Preliminary investigations indicate the take-off run was uneventful, until the aircraft lifted from the ground about 50ft then came down on the left main gear after which it veered off the track to the left. It hit a tree on the left side of the airstrip with the left wing and swung more than 360 degrees coming to a halt after hitting another tree 30meters away, ripping off the entire empennage.

The engine was found 10meters detached from the main wreckage.
